**OIL & GAS
REMEDIATION SITE STATUS
REPORT | 2016**

**Abandoned Oil and Gas Well / Remediation Site Fund
Remediation Sites
Status Report**

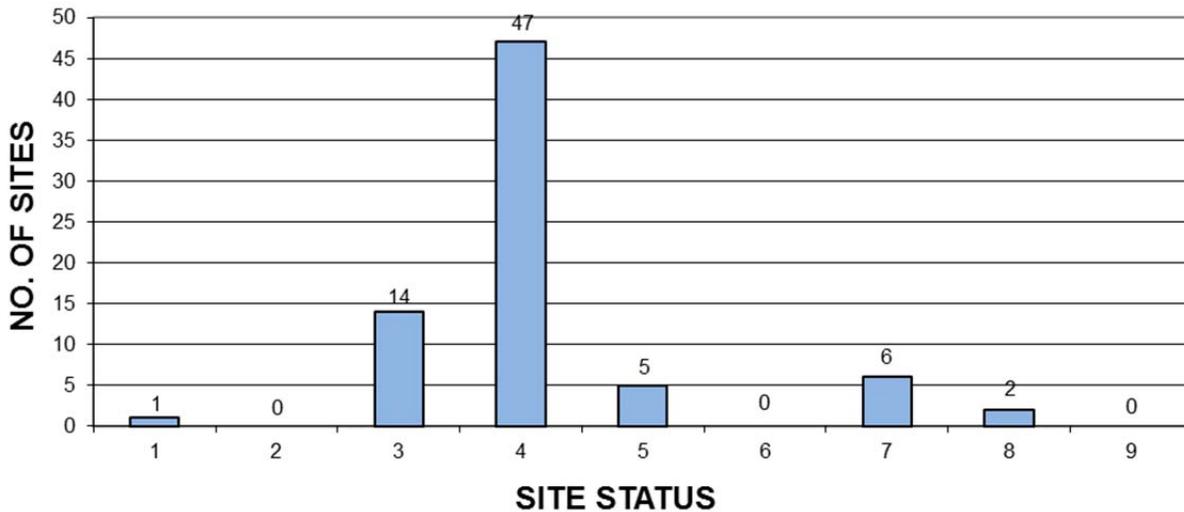
STATEWIDE DISTRIBUTION OF SITES BY STATUS

In general, each contamination site has a definable life cycle. This cycle begins with, then follows a sequence, of investigatory and possible remedial activities which move the site toward ultimate resolution. The first phase of the cycle is the site assessment. This phase defines general site parameters and conditions forming the basis for additional efforts at the site. Once the assessment is complete the site moves on to a new phase. This next phase may be short term or long term monitoring followed by resolution of the site. Another scenario might include an extensive investigation phase followed by the installation of a monitoring system whose sample results may indicate the necessity for certain remedial activities and additional post remediation monitoring prior to resolution of the site. The following graphs depict the current status of the 51 listed sites on a statewide and KCC District basis.

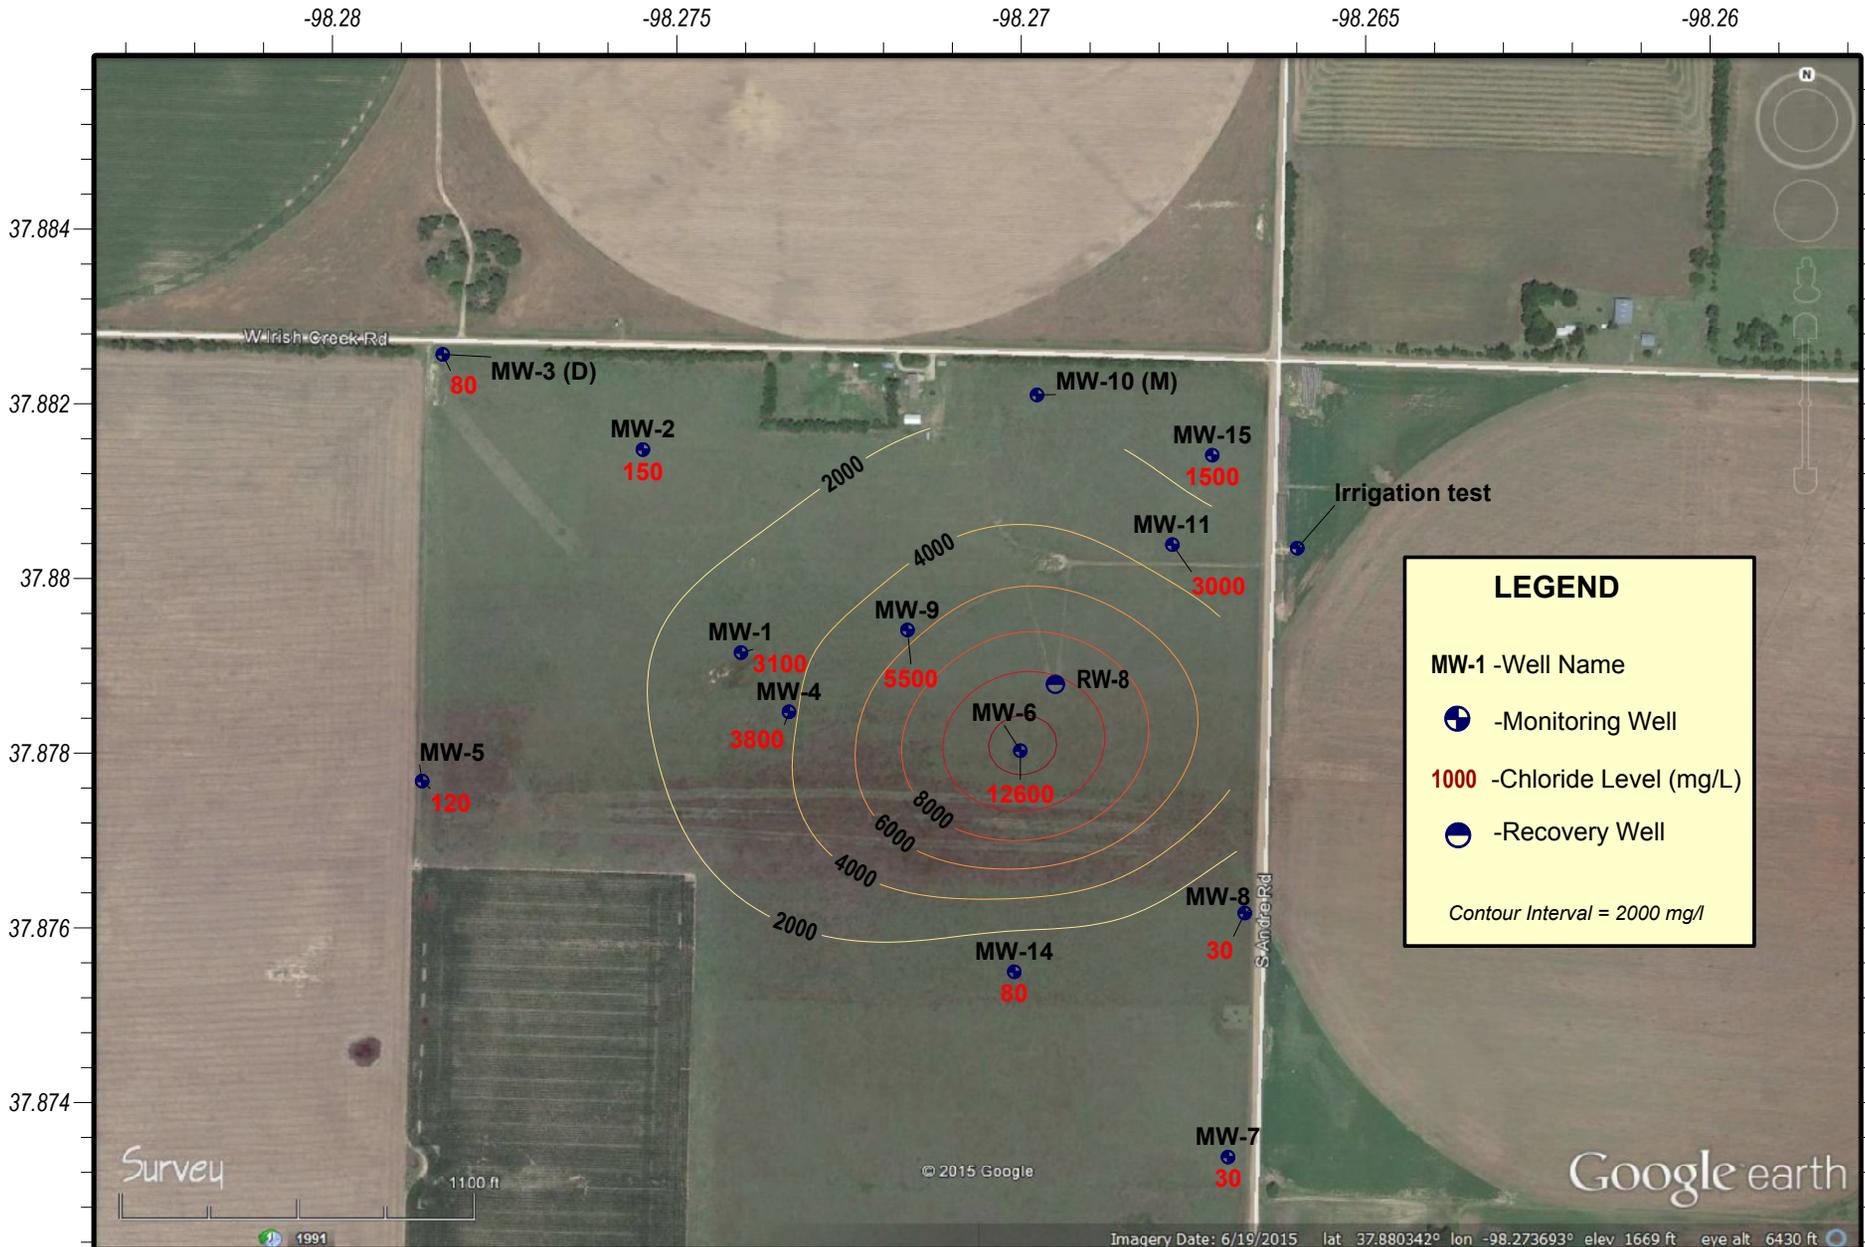
Status of the Project: Since 2001 Rama Operating Company has installed 16 monitoring wells and 8 recovery wells within the area of the Arlington contamination Site. From late 2010 to 2014, Rama has been allowed to move the site into post remediation monitoring. Up to that time Rama had utilized the recovery wells in an effort to remediate the immediate groundwater onsite. Rama installed a pump and lines to RW-8 and ran that recovery well during the summers of 2014-15 after chloride levels were found to remain high. Annual sampling by KCC has shown that the chloride plume has stayed mainly contained in the NE/4 of section 14, with the highest levels of chlorides found in MW #6 (12,600 mg/L). Chlorides have increased in many of the wells surrounding that recovery well. The overall water level has fallen by an average of 1.72 feet since 2014. Water level drop may be the reason behind the elevated chlorides tested during the late summer of 2015. Bedrock mapping of the Harper Siltstone indicates a slight depression along the bedrock at MW #6, therefore contains the highest concentration of saltwater in this feature. 2015 groundwater elevations indicate that the generalized flow is to the east-northeast, and there was a hydraulic gradient between MW-5 and MW-11 of 0.001509128 ft/ft. It should be noted that RW-8 was running during water level measurements, and it is assumed that this well has the ability to affect local groundwater and hydrology to a limited extent.

On October 15, 2015, KCC was onsite to sample the monitoring wells via air lift technology. MW-10 was repaired but not sampled as the repair was not solid enough to handle air lifting; this well will be sampled next year after sturdier repair work is done to the well. Prior to sampling, groundwater levels were measured in each monitoring well using an electronic water level indicator. Air-lift technology was used to purge a minimum of three well volumes of groundwater from each well, save MW-15 which was pumped via submersible Proactive® Water-Spout water pump. Purge water was tested for conductivity and contained in a 250 gallon poly-tank if conductivity was high before disposed of into a deep injection well. Groundwater samples from each monitoring well were collected in one 250 (ml) polyurethane container for analysis at the KCC District 2 Laboratory. Each sample for this monitoring event was analyzed for the presence of Chloride by United States Environmental Protection Agency USEPA Silver Nitrate Buret Titration Method - Method 8225.

Arlington Contamination Site
 Section 14 - Township 25 South - Range 9 West, Reno County, Kansas
2015 Chloride Levels
 KCC Project code #20030016-001 - KCC District #2 Field Office
 Well Sampled on 10/15/2015 - Map Drawn on 11/16/2015 by D. Bollenback

Recommendation for Future Work: It will be suggested to Rama Operating Company, to continue to run Recovery Well No. 8, and any possibly other recovery wells adjacent to MW #6 in an effort to expedite the remediation efforts since natural attenuation will not likely occur anytime soon. RW-8 is the closest recovery well to the "hot spot" in the plume and should have a positive effect on chloride levels. This year showed elevated chlorides which could be the result of lower groundwater elevation along with the pulling of higher chloride fluids toward the recovery well. KCC recommends continuing to monitor in 2016-2017.

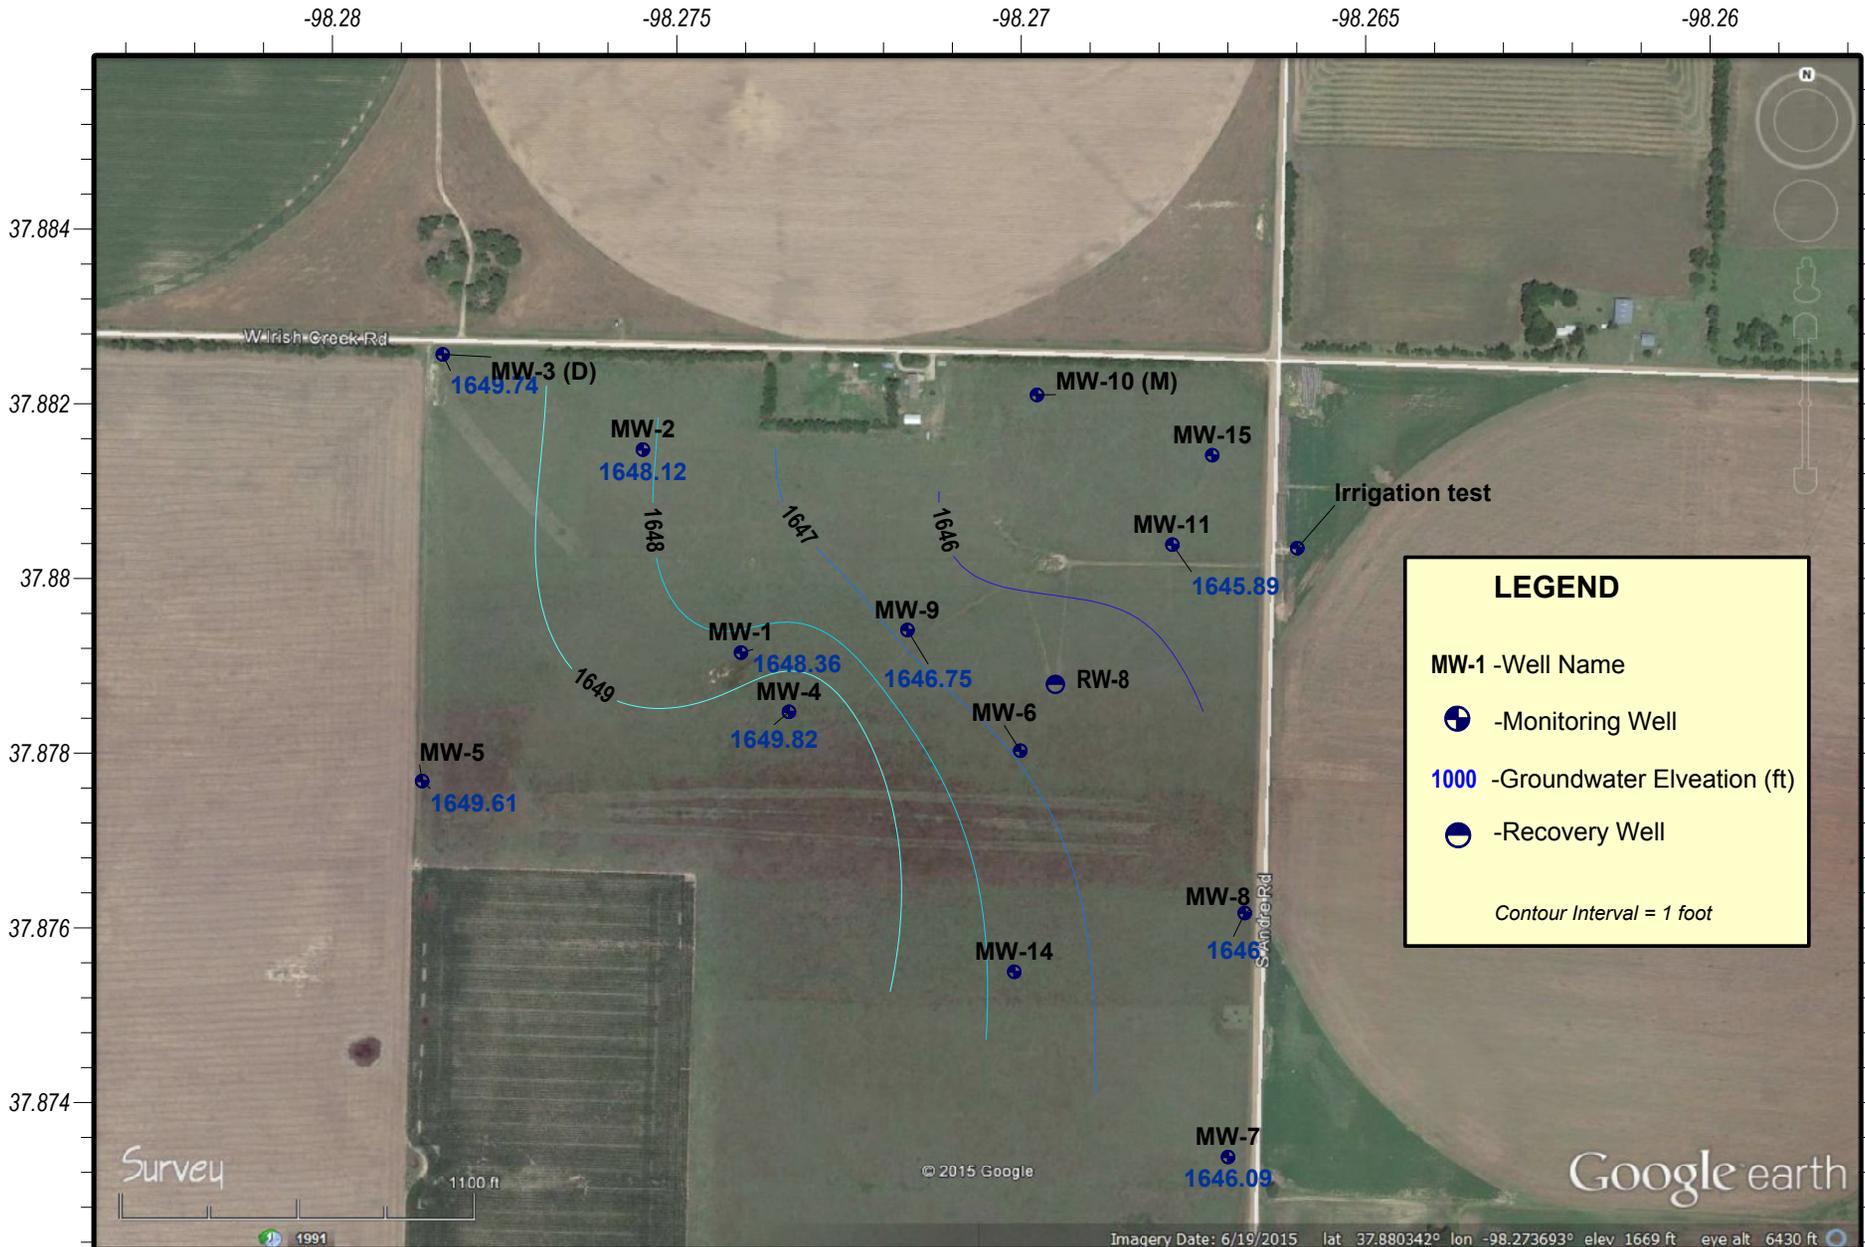
Arlington Contamination Site
 Section 14 - Township 25 South - Range 9 West, Reno County, Kansas
2015 Groundwater Elevations
 KCC Project code #20030016-001 - KCC District #2 Field Office
 Well Gauged on 10/15/2015 - Map Drawn on 11/16/2015 by D. Bollenback

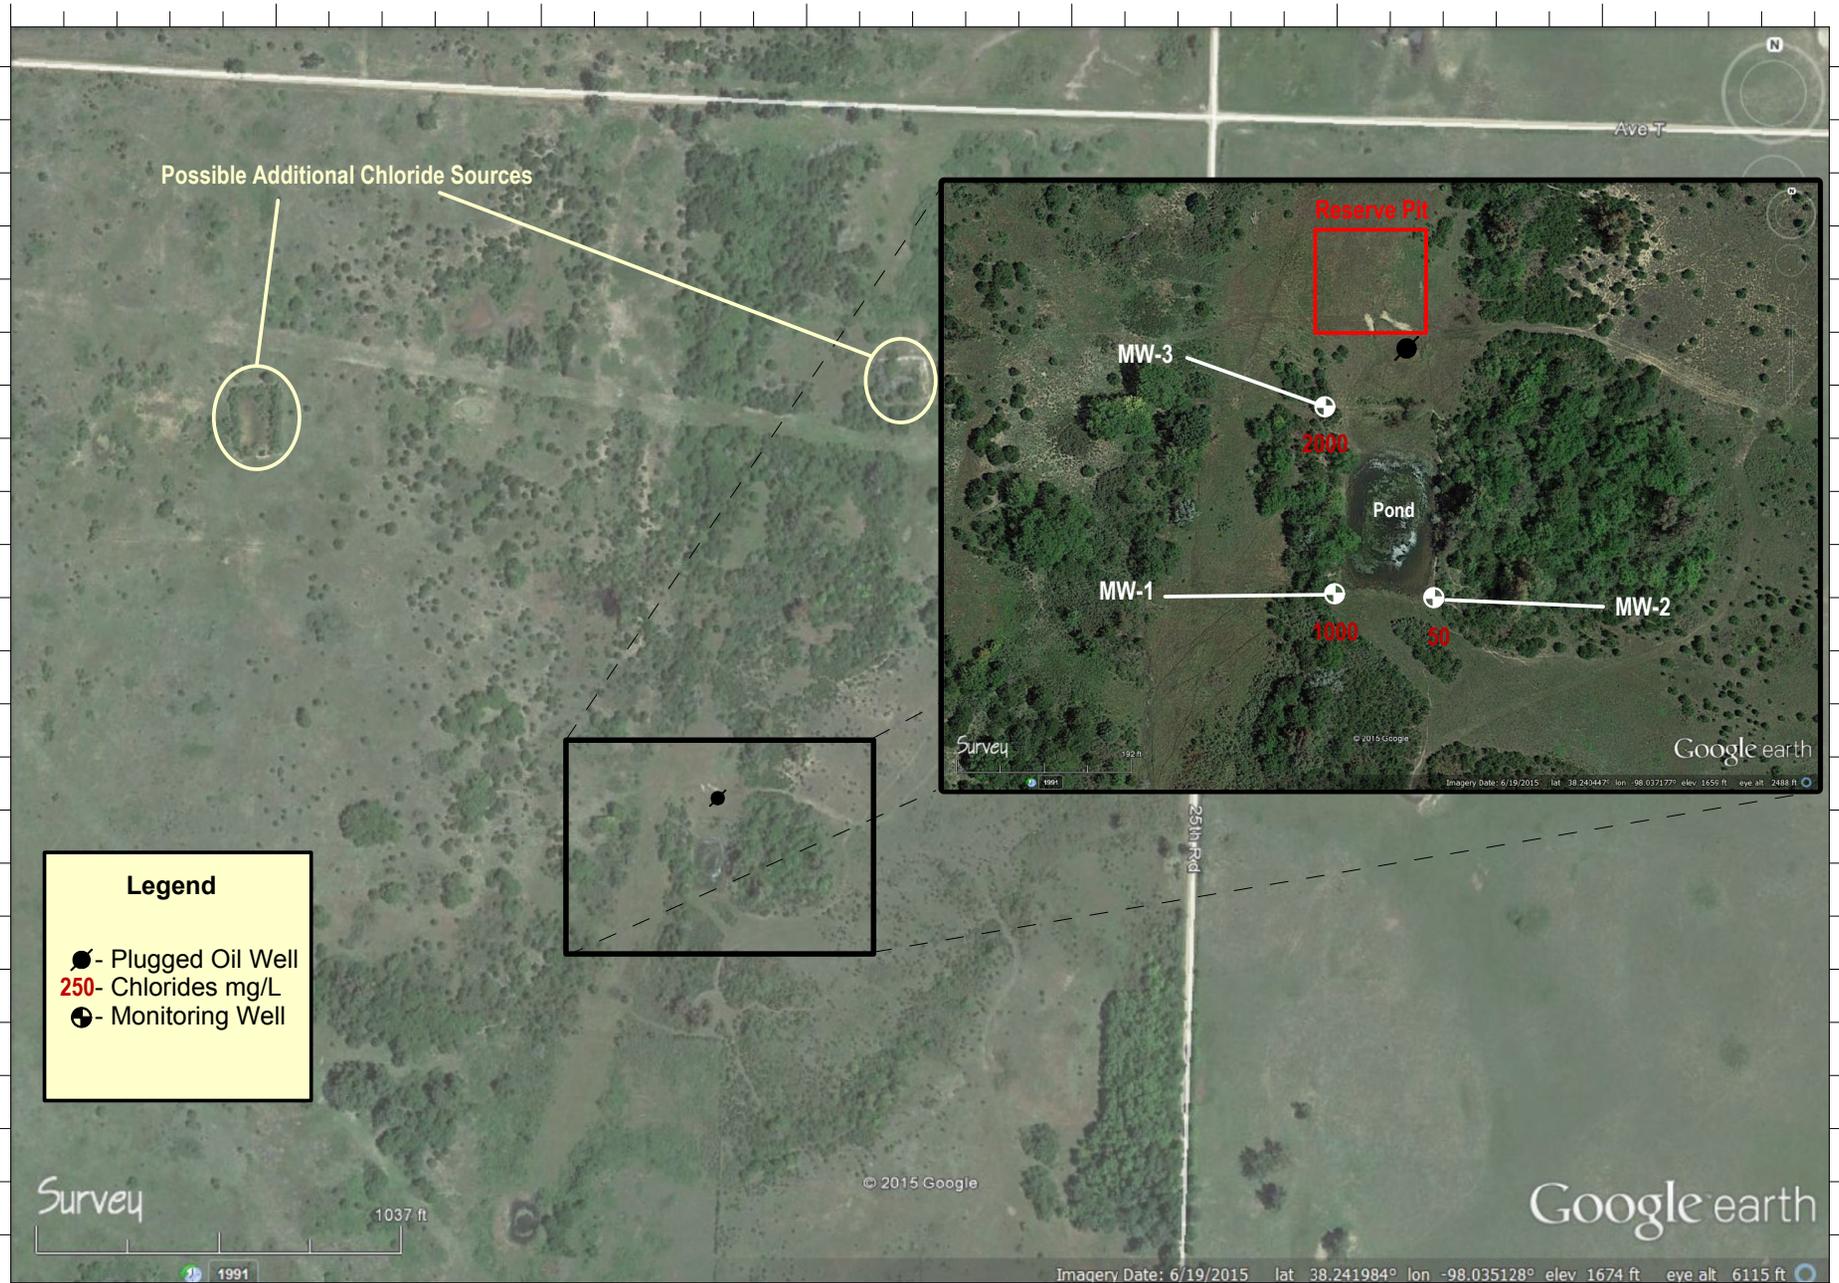
Site Description: The site is located in the Sand Hills of Rice County. The groundwater aquifer is a shallow permeable zone consisting of loose fine-grained sand underlain by a thick clay layer. The groundwater flow is to the south-southwest.

Brothers Chloride Monitoring Site
 S/2 NE of Section 12 of Township 21 South & Range 7 West, Rice County, Kansas
2015-16 Chloride Levels and Site Map
KCC Code #970029-00 - KCC District #2 Field Office - Well Sampled on 4/21/2015 - Map Drawn on 10/23/2015 by D.Bollenback

Recommendations for Future Work: KCC recommends that the site remain in the monitoring phase due to the lack of priority of the site. In the future, KCC recommends that a Geoprobe® rig be used to probe the area surrounding the site. Probe work could indicate whether or not the chloride contamination is still high in the old drilling pit area. Probe work could also show whether or not this chloride contamination is part of a larger chloride situation from past oil field activities. Data found from a probing event could be used to help plan on a timetable for site closure or help indicate other avenues of remediation in order to hasten cleanup.

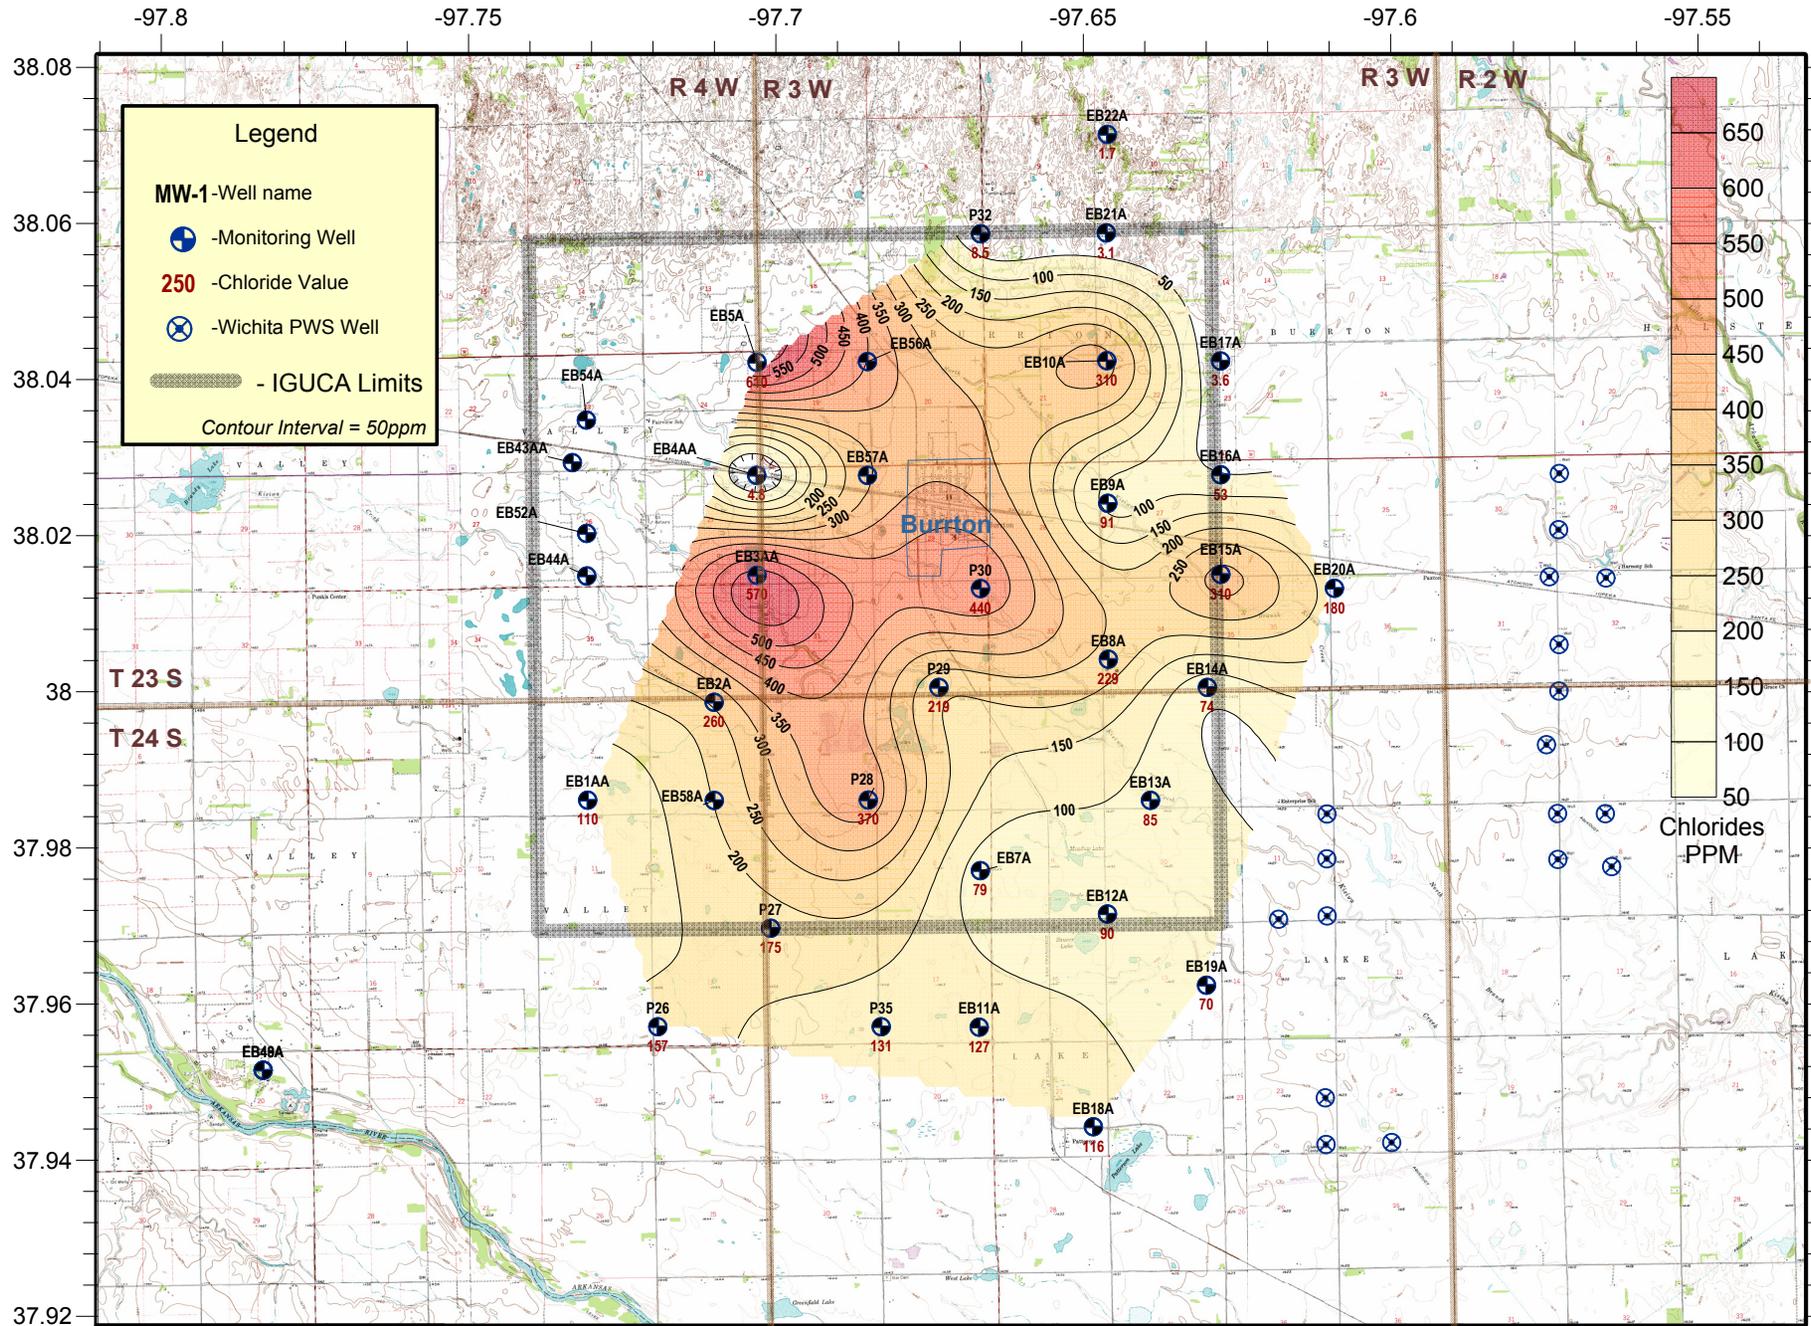
Burton IGUCA Brine Contamination Field
A Zone Chloride Map Showing GMD#2 Groundwater Well Data from 2015
 Reno and Harvey Counties, Kansas
 KCC Project Code #970042-00 - KCC District #2 Field office - Map drawn on 10/28/2015 by D. Bollenback

Recommendations for Future Work: Continue cooperating with Groundwater District 2 including the funding of annual water well sampling and analysis of this critical data. KCC will continue to review data for locations for possible additional wells to help delineate the plume. Open communication with the USGS, City of Wichita, and GMD #2 regarding data exchange and future cooperation is essential for the study and remediation of this problem. KCC will concentrate research into high level A Zone plumes to investigate the possibly of remedial action in smaller areas of contamination.

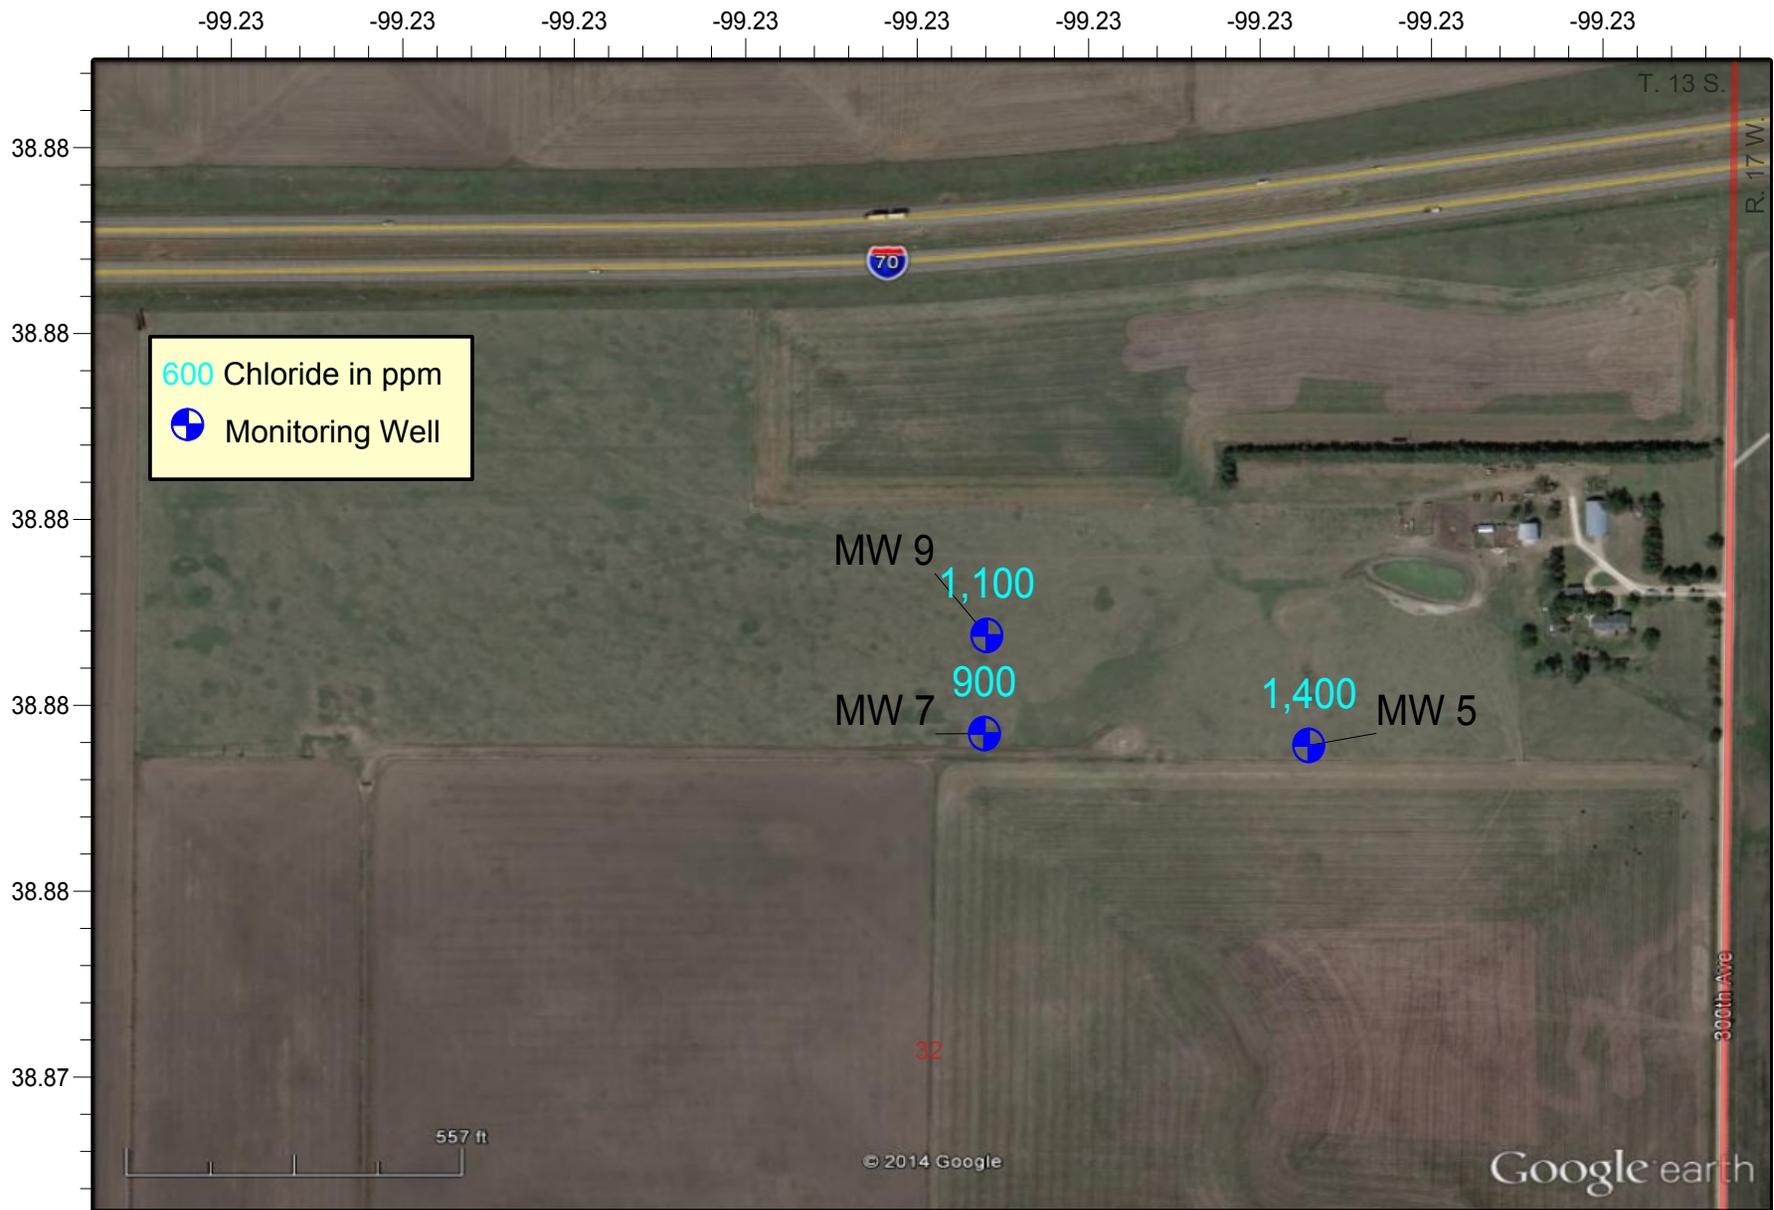
Dinkel Groundwater Monitoring Site
 Section 32 of Township 13 South, Range 17 West, Ellis County, Kansas
 2015 Groundwater Chloride Levels
 District #4 - Sampled 8/27/2015 - Map Drawn on 9/10/2015 by C. Neeley

Recommendations for Future Work: Annual sampling will continue at this site.

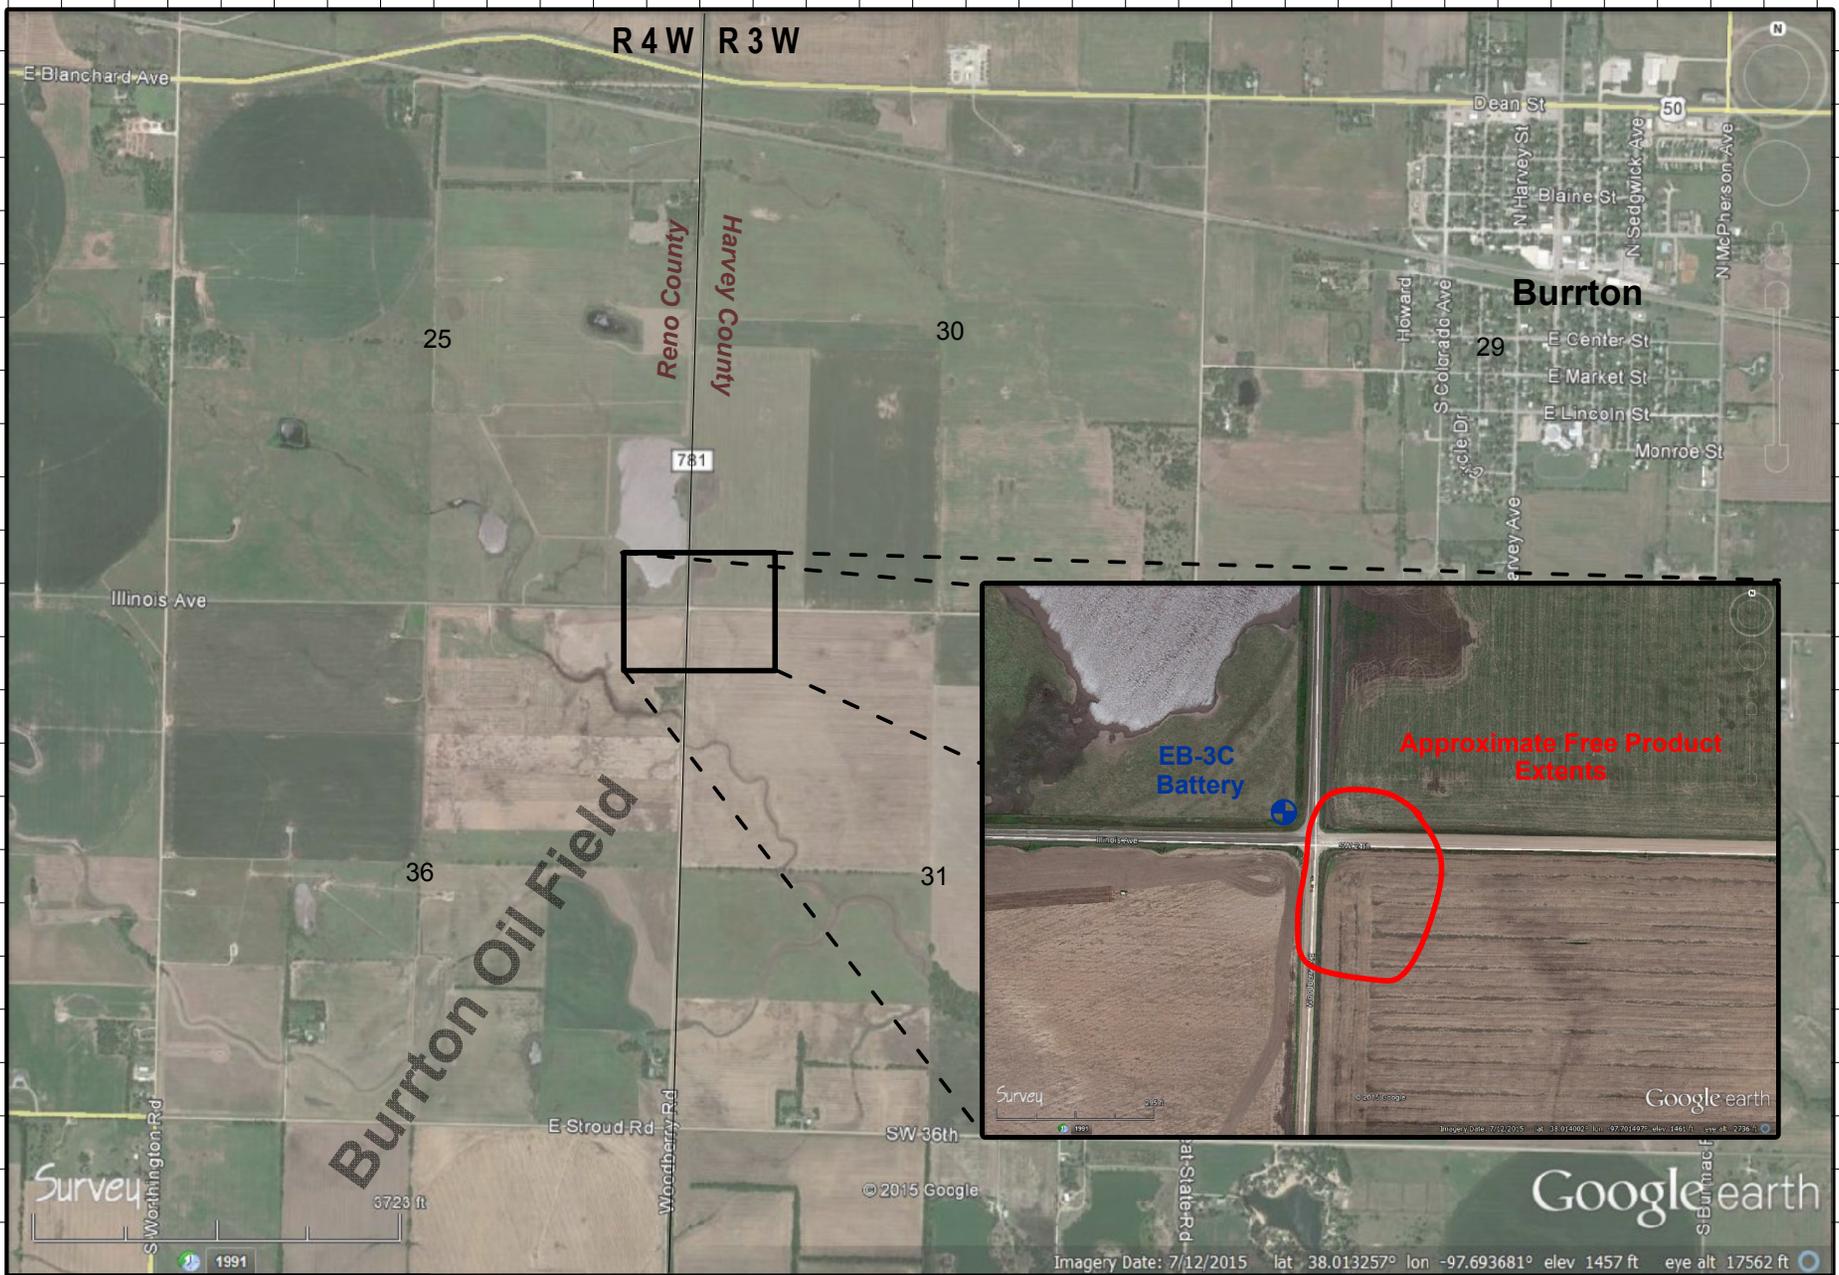
Burrton EB-3C - Crude Oil Spill
 Sections 30 & 31 - Township 23 South and Range 3 West, Reno County, Kansas
Annual Site Map 2015-16
 KCC District #2 Field Office - Map Drawn by D.Bollenback on 10/27/2015

Recommendations for Future Work: Nothing at this time as the site is listed as low priority and there have been no water wells drilled in the immediate area. In the future KCC may look into the use of an emulsifier to work in hand with the oxygenating treatment. The oxygenating compounds will continue to help breakdown any contaminates in aqueous form. After sufficient improvement is found KCC will close the site.

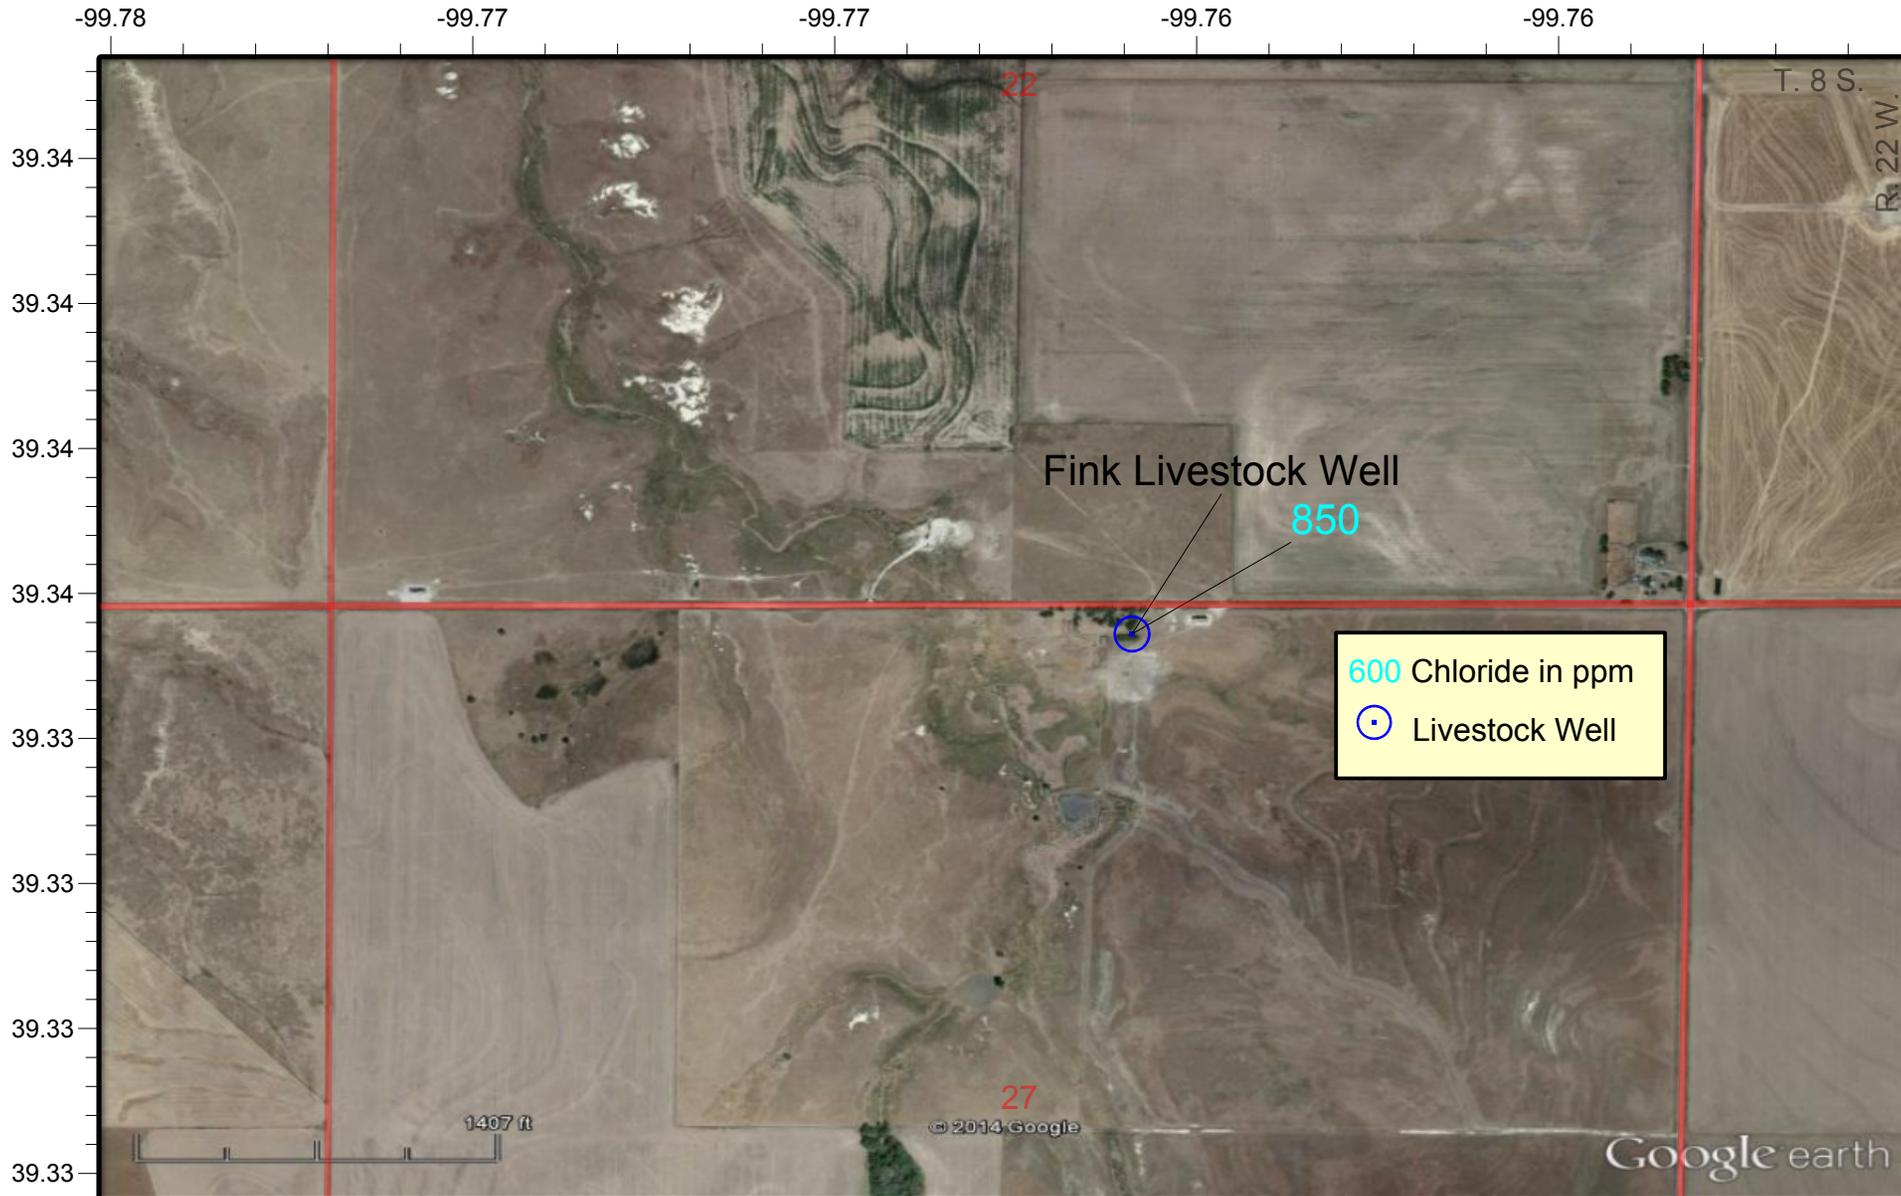
Status of Project: The domestic well has been abandoned due to a water level that is inadequate for use by the owner, and the house has been abandoned as well. The last sample taken from this source, in 2004 contained a chloride concentration of 200 ppm. Samples from the stock well continue to be tested, and the well is presently being utilized for livestock which will contribute to a reduction in chloride concentrations if the source has been eliminated. An overall downward trend has been observed over the history of the site, and the current contamination concentration is at 850 ppm.

Leon Fink Groundwater Monitoring Site
 Section 27 of Township 8 South, Range 22 West, Graham County, Kansas
 2015 Groundwater Chloride Levels
 District #4 - Sampled 10/29/2015 - Map Drawn on 10/29/2015 by C. Neeley

Recommendations for Future Work: This site should be monitored long-term to ascertain if the source of chloride ions has been isolated from the useable water in the Codell Sandstone aquifer. An investigation of the Fink #2 and the water well should also be conducted.

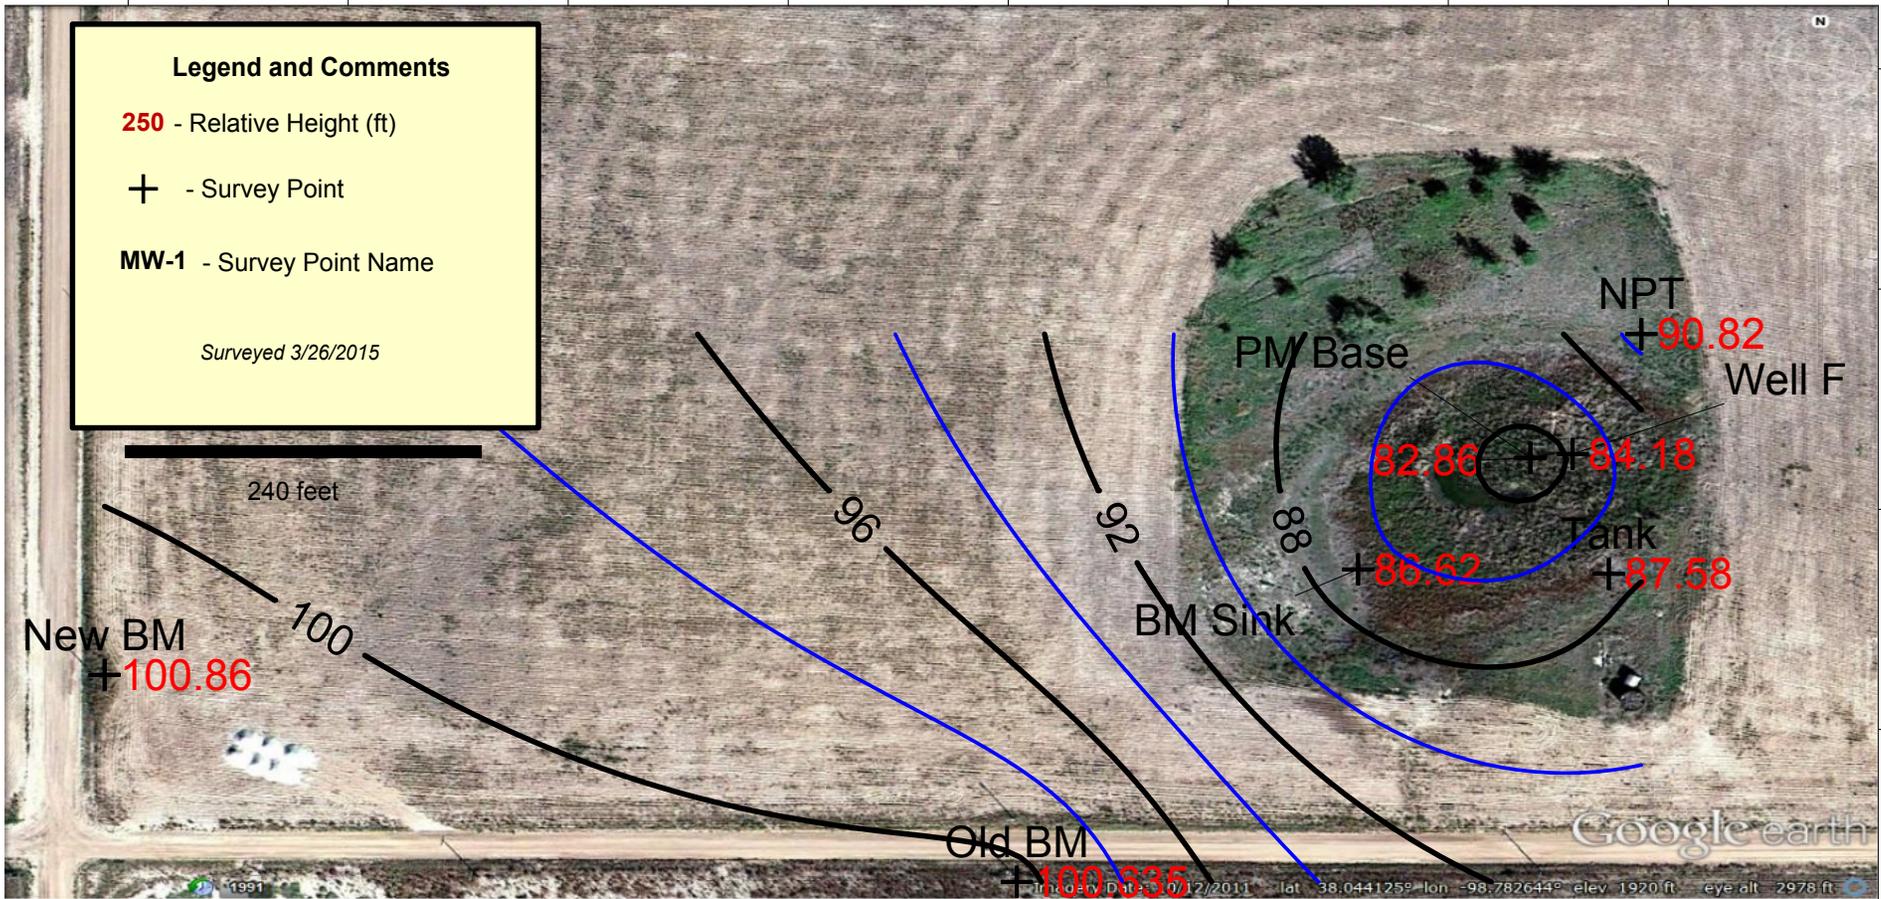
French Sinkhole
 SW 1/4 Section 17-T23S-R13W
Change in Elevation Map
 KCC Control #970002-001 District #1
 K. Sullivan 5/1/2015

Recommendations for Future Work: Monitor stock wells and irrigation wells to the southeast of the depression. Resume the annual survey of the site to establish a current rate of subsidence. Monitor possible second depression to the southeast of the original depression.
