**OIL & GAS
REMEDIATION SITE STATUS
REPORT | 2016**

**Abandoned Oil and Gas Well / Remediation Site Fund
Remediation Sites
Status Report**

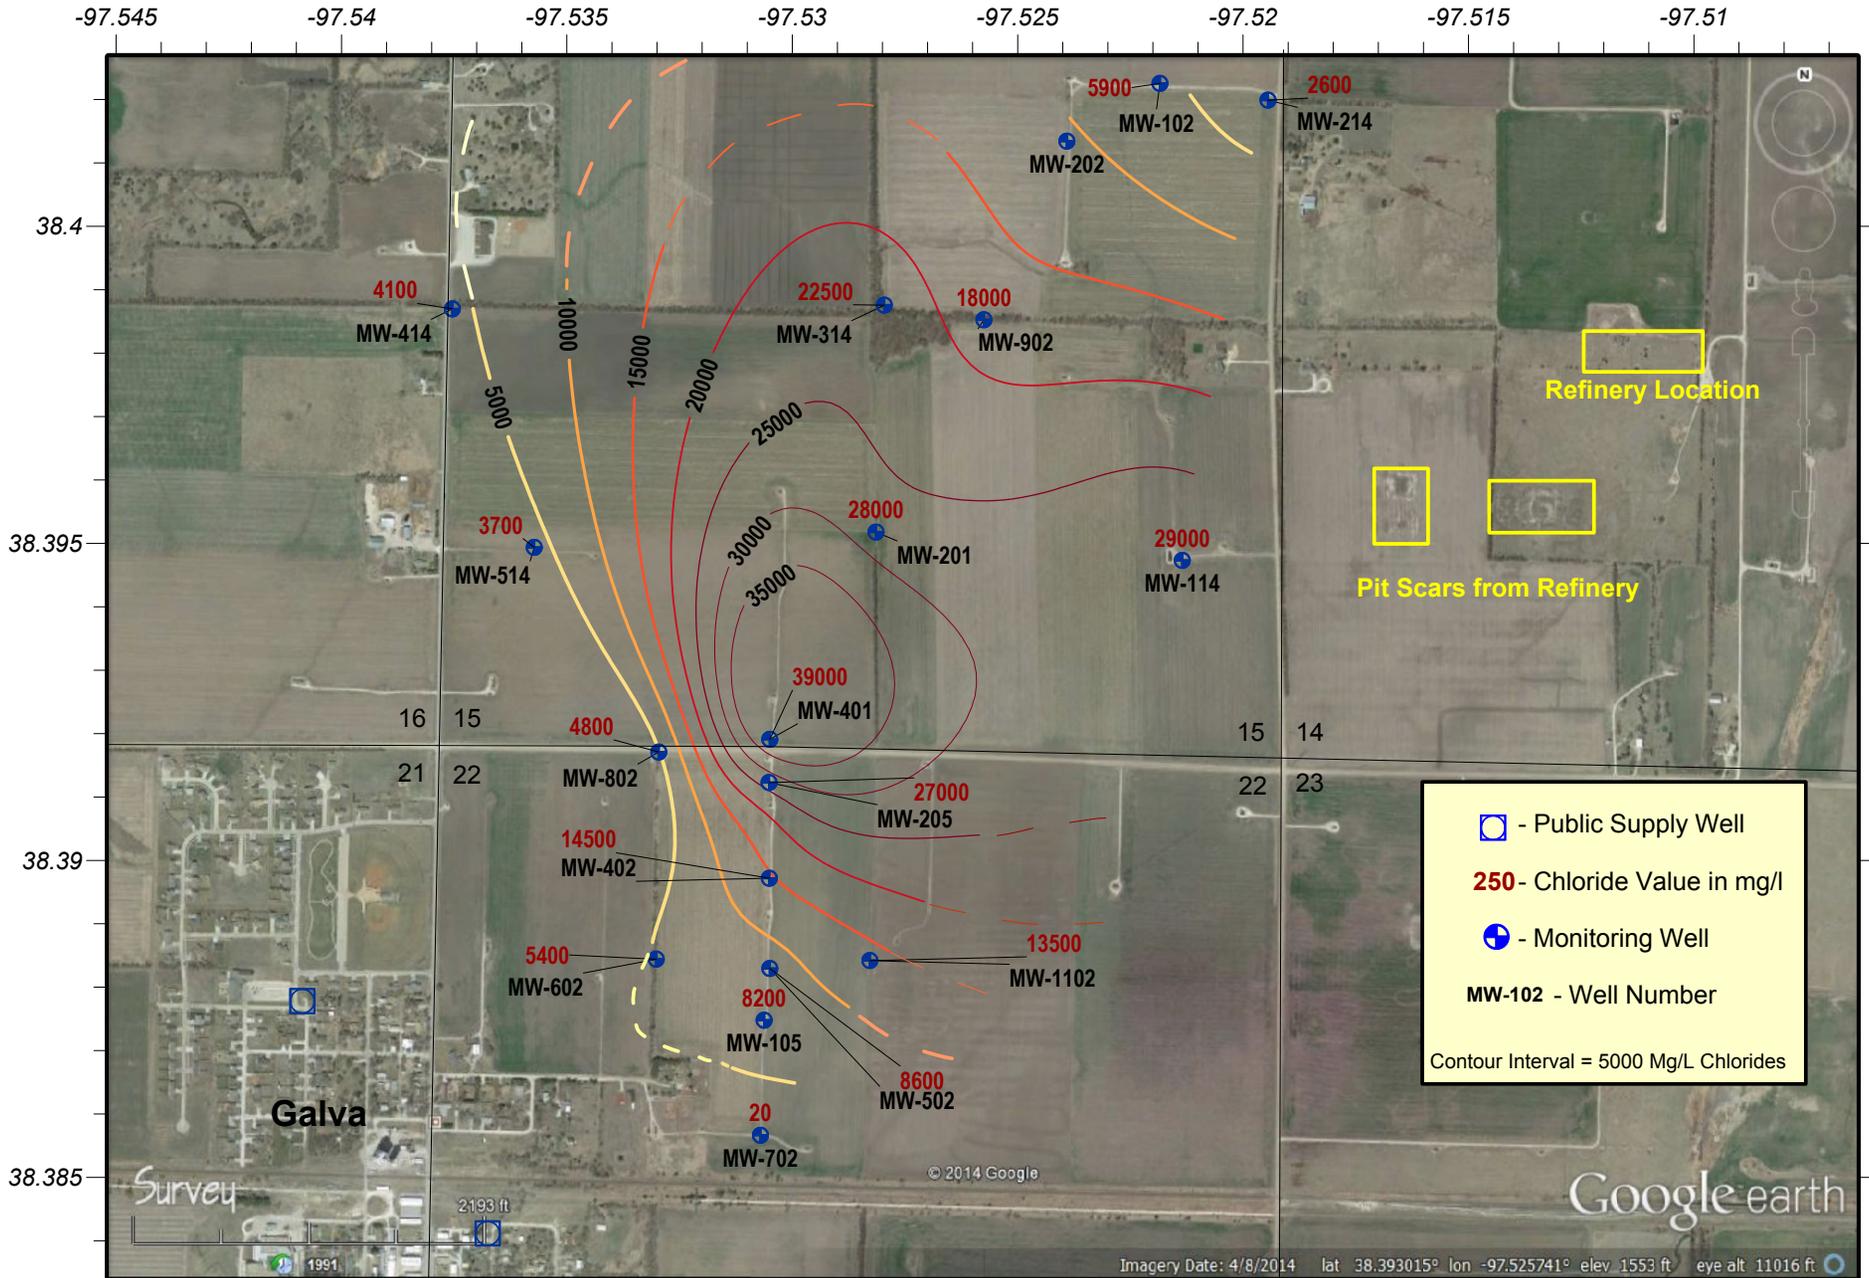
The extremely high chlorides across the site showed stability during 2015 except for the monitoring wells within the radius of influence of RW-3 which has increased. It should be noted that RW-3 had a pump failure which took it offline for 6 months while KCC bid out the work for replacement. Recovery well sampling have shown a drop in chlorides in all the recovery wells over the lifetime of the system. RW-3 was put back online on October 4, 2015, and was metered at pulling 55 gallons per minute with a chloride level of 25,500 mg/L. Recovery wells sampled on November 2, 2015, shows chloride levels of; RW-1(7,200 mg/L), RW-2(7,500 mg/L), RW-3(23,500 mg/L), and RW-4 (1,300 mg/L). It was noted that RW-3 has dropped 2,000 mg/L in the one month it has been back in operation.

Galva City Brine Remediation Site
 Sections 15, 16, 21, and 22 of Township 19 South and Range 2 West, McPherson County, Kansas
2015-16 Chloride Levels
 KCC Control #980033-01 - KCC District #2 Field Office - Map Drawn on 11/18/2015 by D.Bollenback

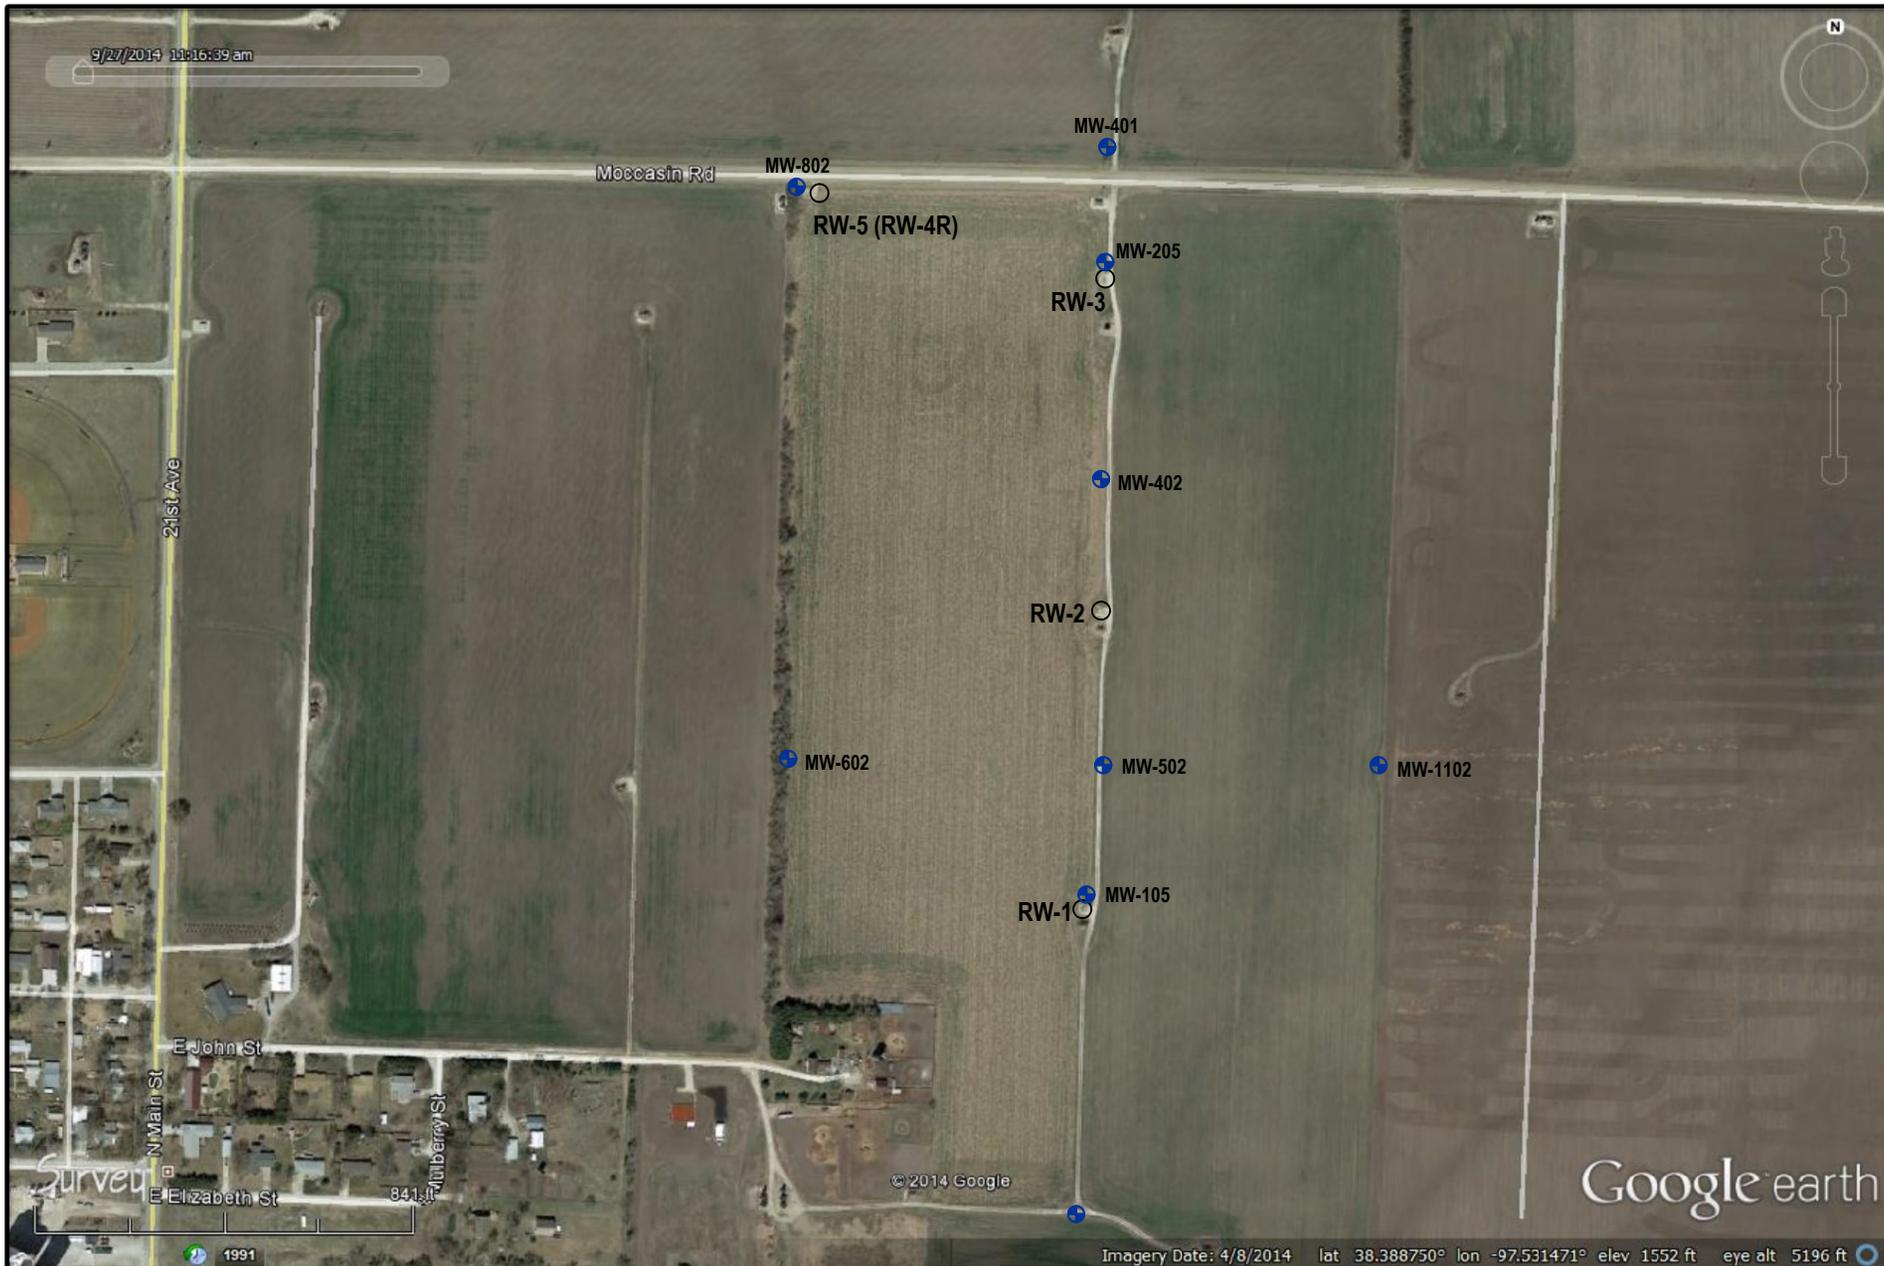
Galva Remediation Site
Recovery Well Locations and Site Map

Unusual Problems: The disposal well will not take the amount of fluid necessary run all four recovery wells at the same time. High Chloride water deteriorates metal pumps, fittings, etc. Recovery pumps have short life spans and the local groundwater has high levels of iron which clog up lines and equipment. The age of the site requires constant vigilance into inspection and proactive and reactive repairs/modifications in order to keep it online.

Late 2014 through early 2015 the system was down while KCC repaired the saltwater line that broke underground east of the site. A total of 13,951,300 gallons (332,174 barrels) of brine impacted water was recovered by the system from January 2015 to November 2015.

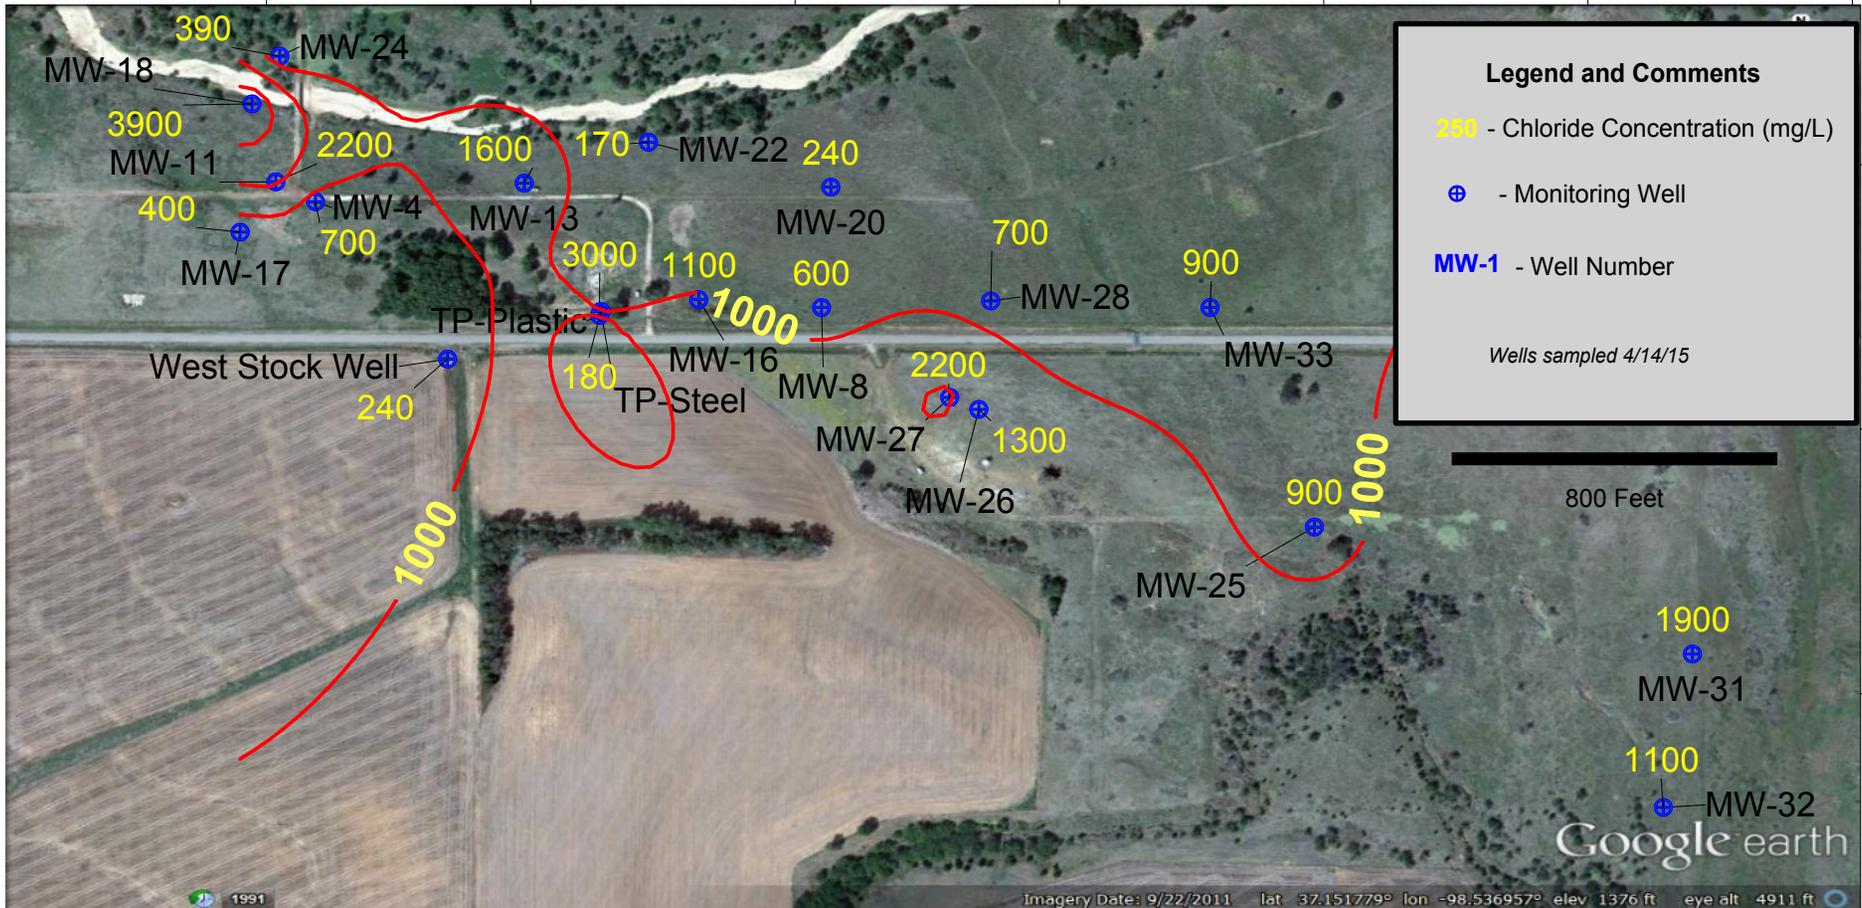
Harbaugh Site
 Sections 20/29-T-33S-R11W
 Barber County, Kansas
2015 Area Map with Chlorides
 KCC Control # 970049-00 District 1
 K. Sullivan 4/14/15

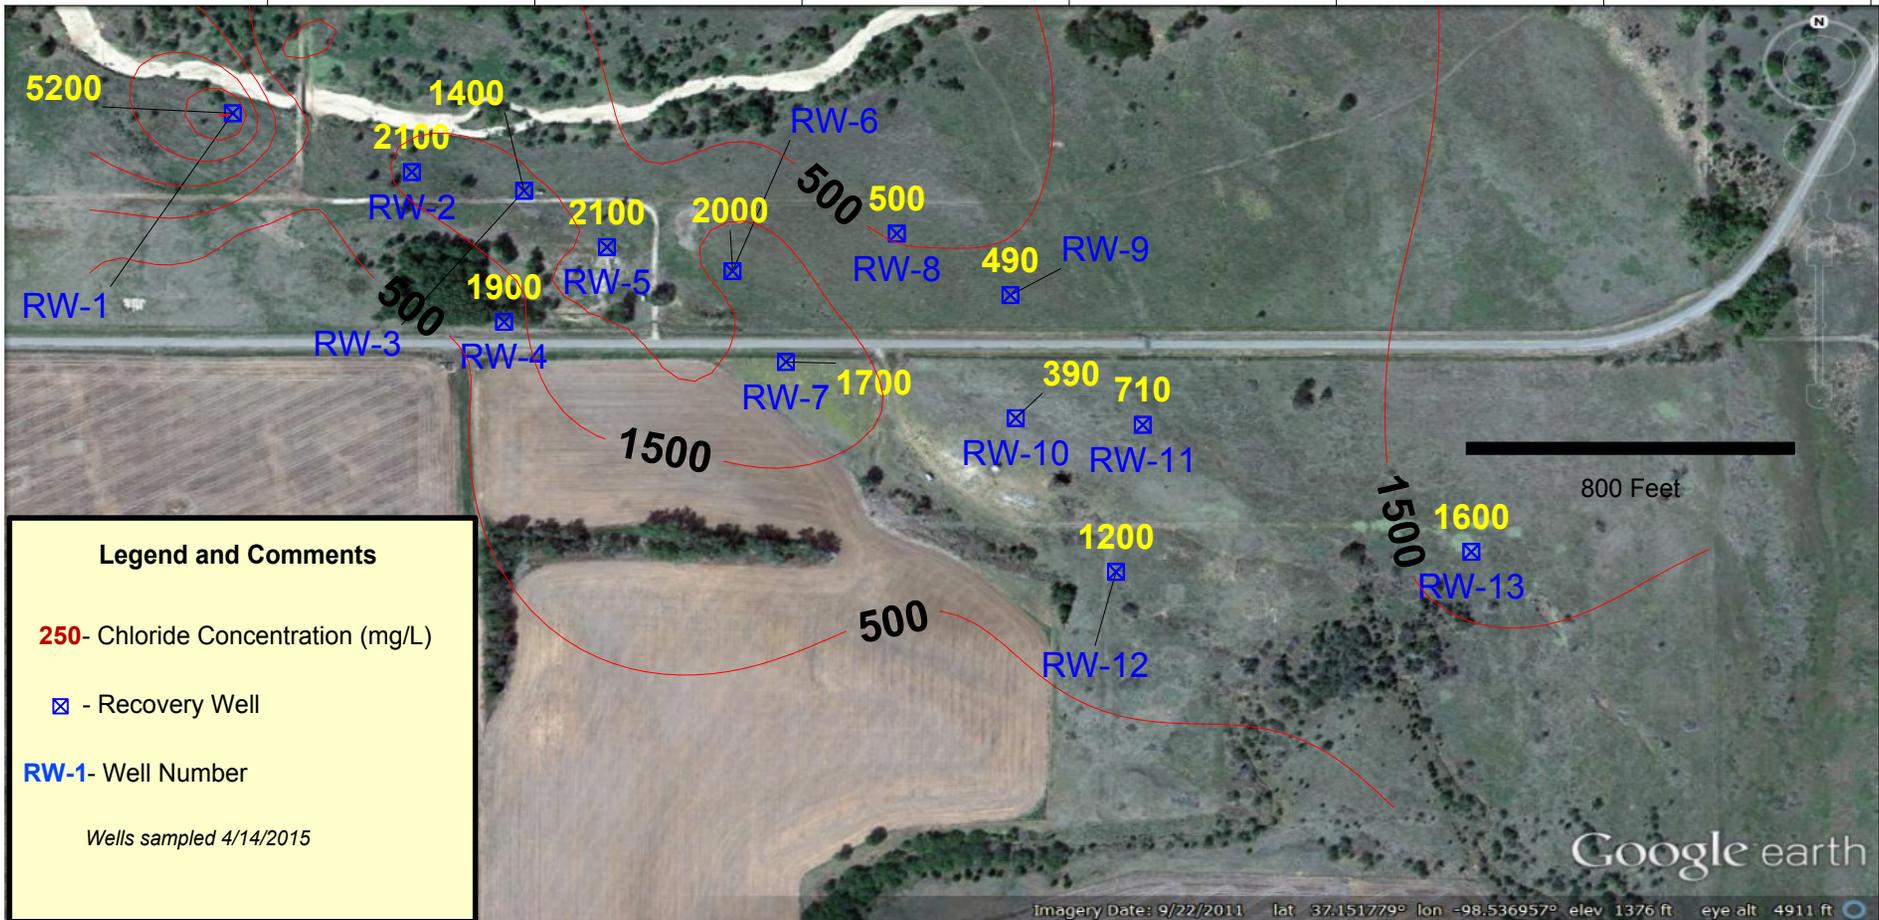
Harbaugh Site
 Sections 20/29-T-33S-R11W
 Barber County, Kansas
2015 Area Map with Chlorides
 KCC Control # 970049-00 District #1
 K. Sullivan 4/29/15

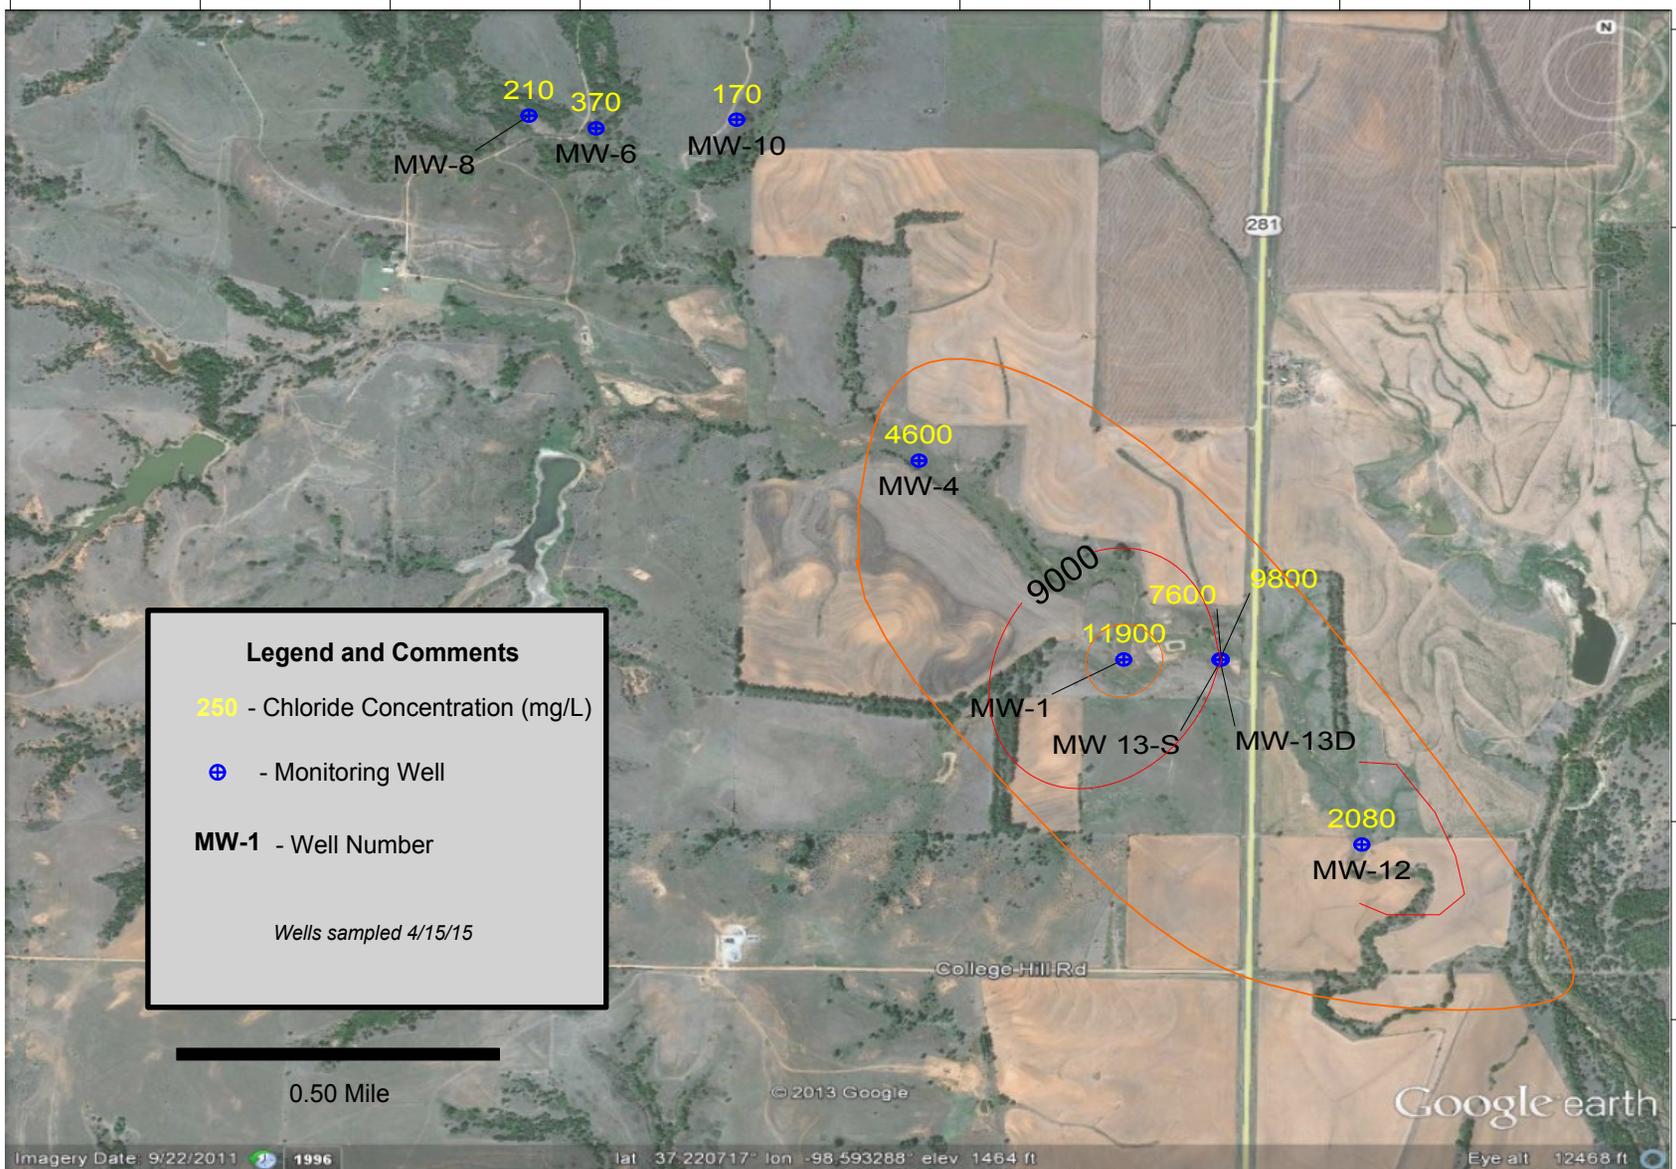
Hrencher Site
 Sections 26/35/36-T-32S-R12W
 Barber County, Kansas
2015 Area Map with Chlorides
 KCC Control # 970051-00 District 1
 K. Sullivan 8/31/15

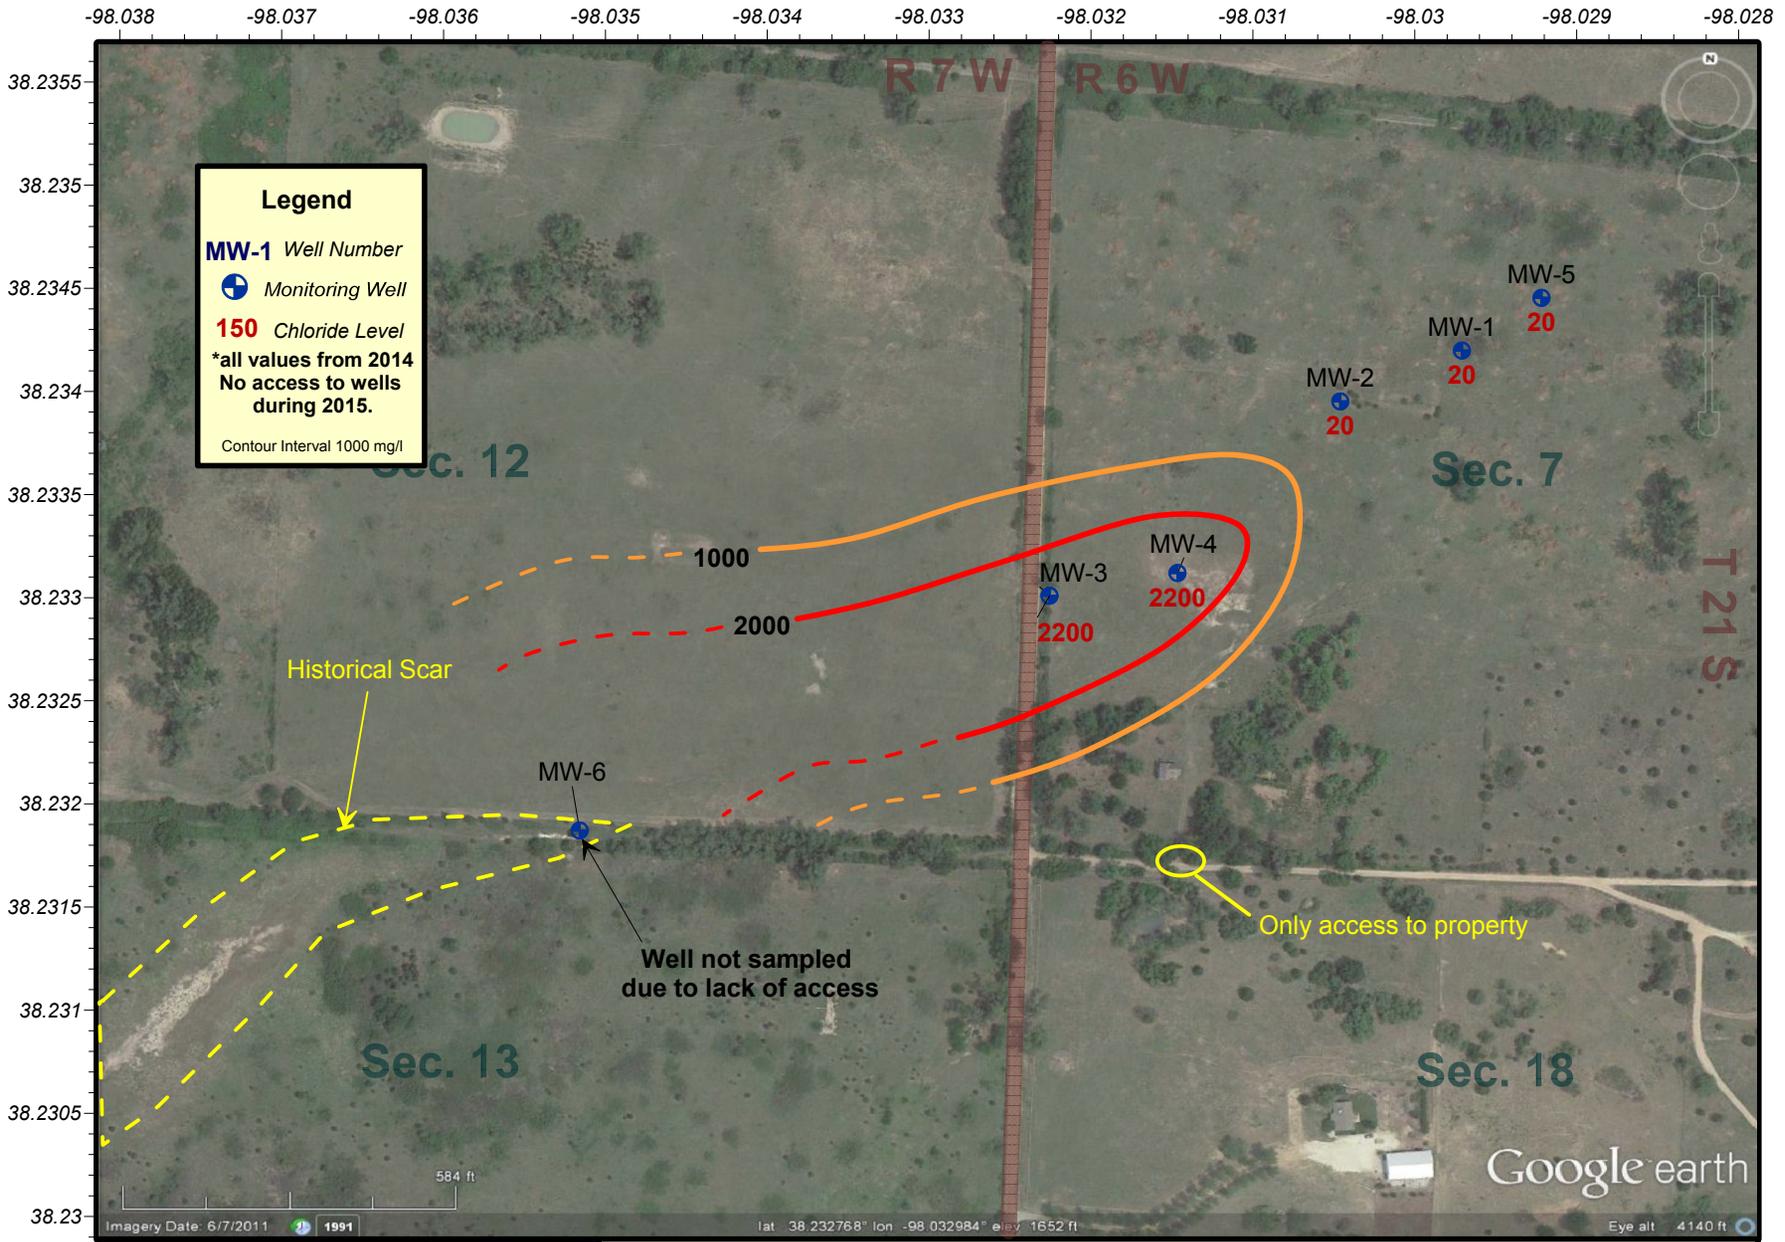
<p>Kansas Corporation Commission</p>		<p align="center">Johnson/Ramsey Monitoring Site - KCC Control # 970055-00 Section 7 of T 21 S & R 6 W, Section 12 of T 21 S & R 7 W and Section 13 of T 21 S & R 7 W Rice County, Kansas 2015 Site Map District #2 - Sampled 7/8/2014 - Map Drawn 11/16/2015 by D.Bollenback</p>
---	--	--

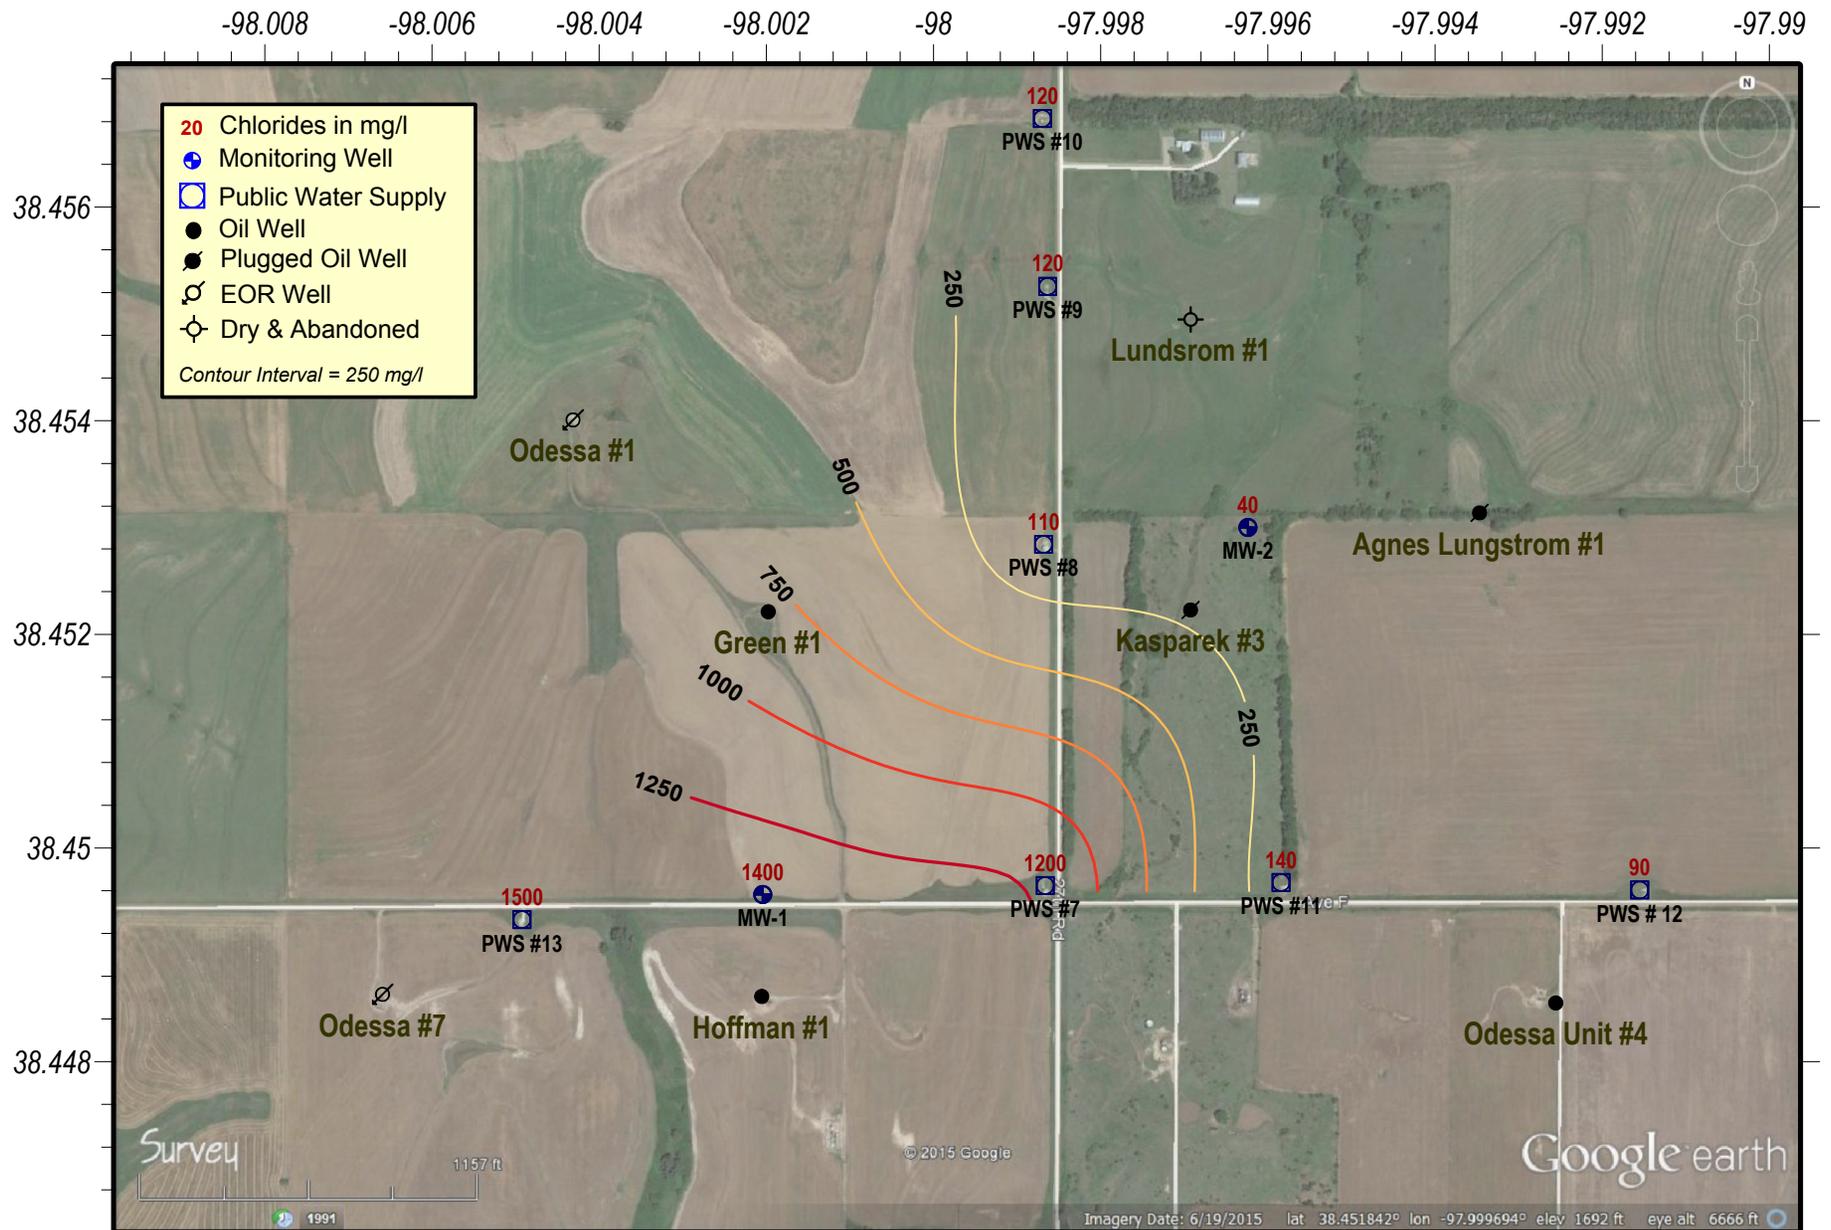
Little River Groundwater Monitoring Site
 Section 29 of Township 18 South & Range 6 West, Rice County, Kansas
2014 Groundwater Chloride Levels
 District #2 - Sampled on 7/1/2015 - Map Drawn on 11/13/2015 by D.Bollenback

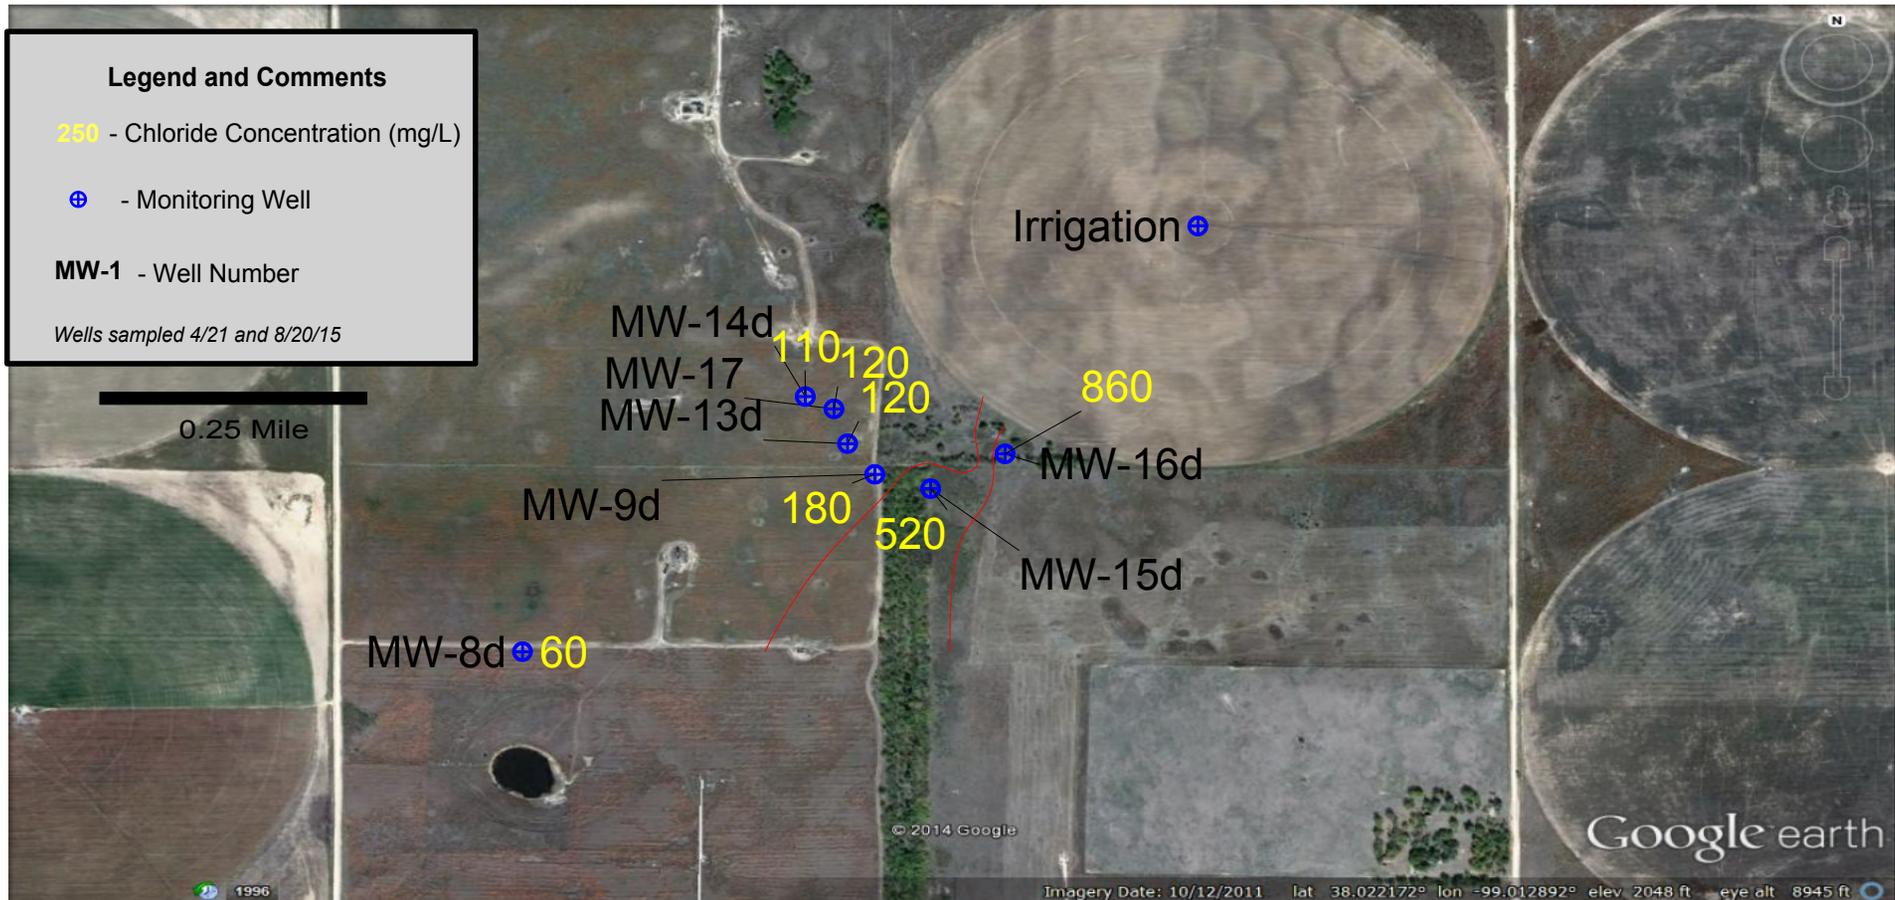
Macksville Site
 Section 30-T-23S-R15W
 Pawnee County, Kansas
2015 Area Map with Deep Depth Chlorides
 KCC Control # 970066-00 District 1
 K. Sullivan 8/21/15

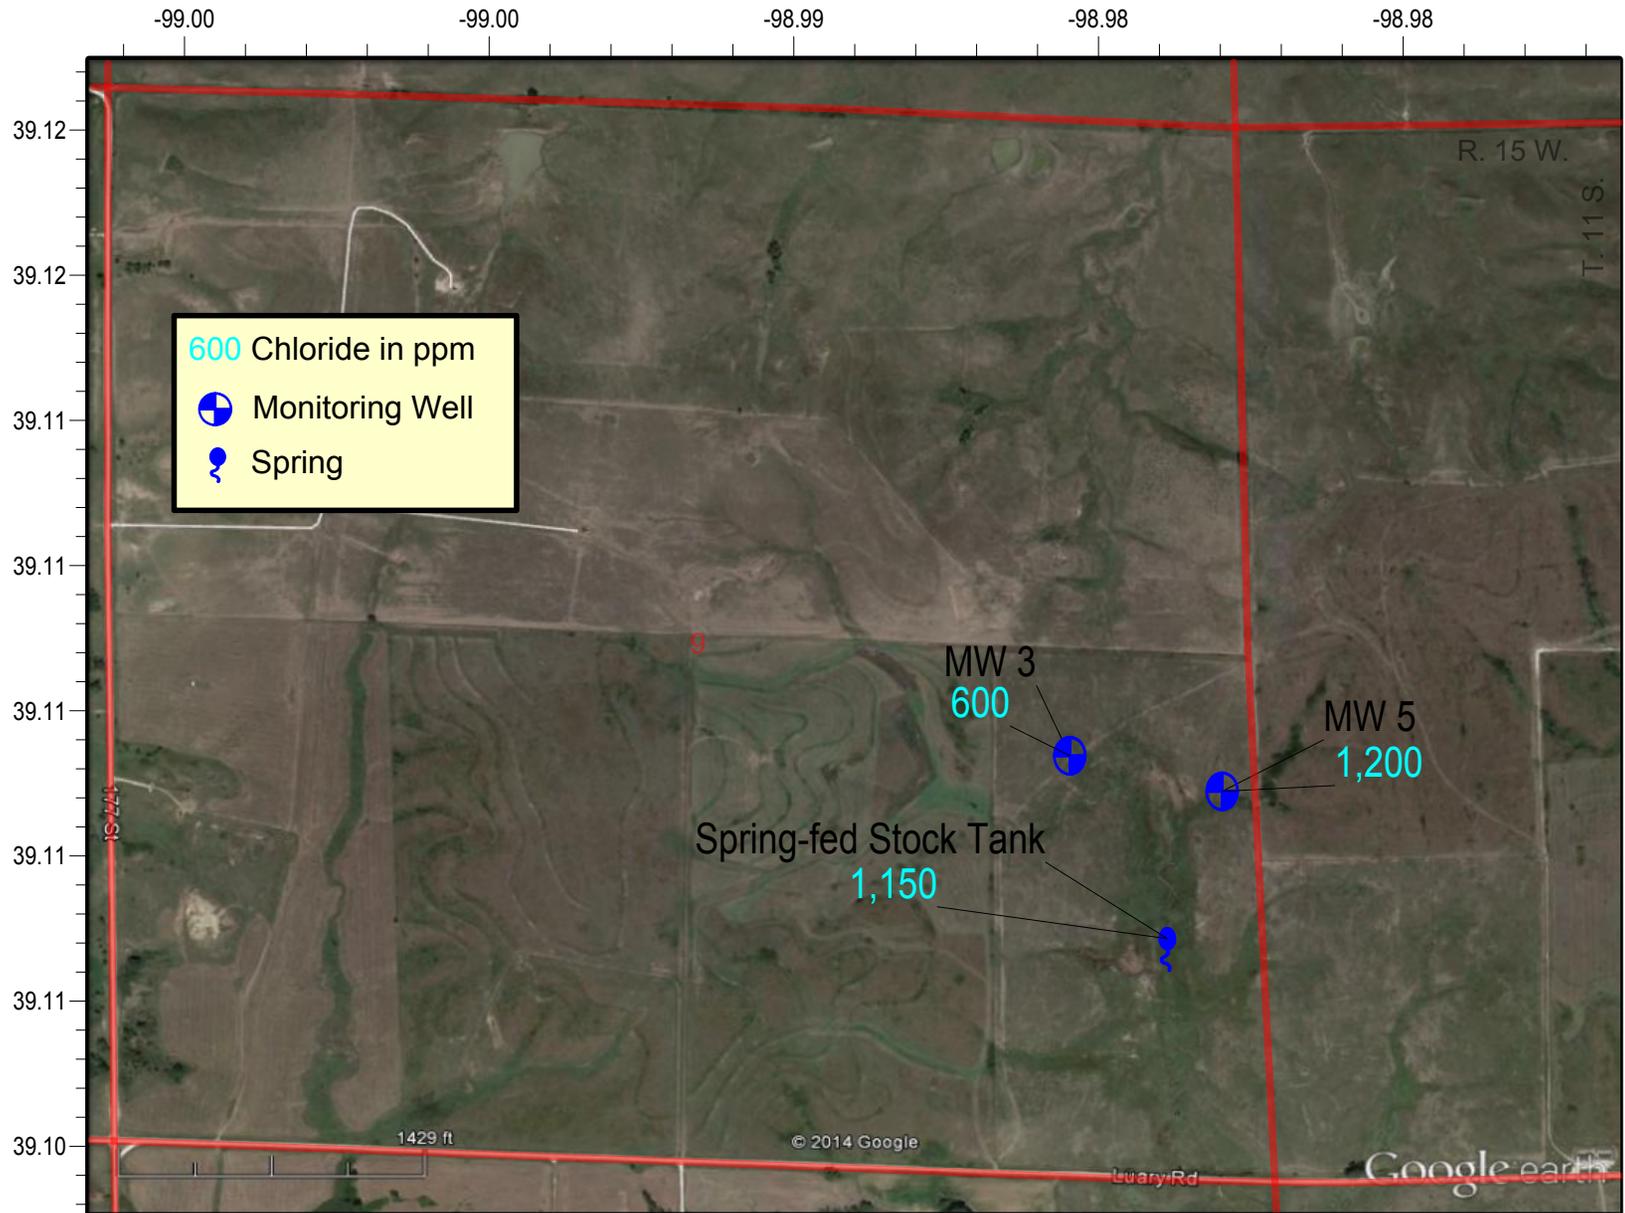
Maupin Groundwater Monitoring Site
 Section 9, Township 11 South, Range 15 West, Russell County, Kansas
 2015 Groundwater Chloride Levels
 District #4 - Sampled on 4/06/2015
 Map Drawn on 4/14/2015 by C. Neeley

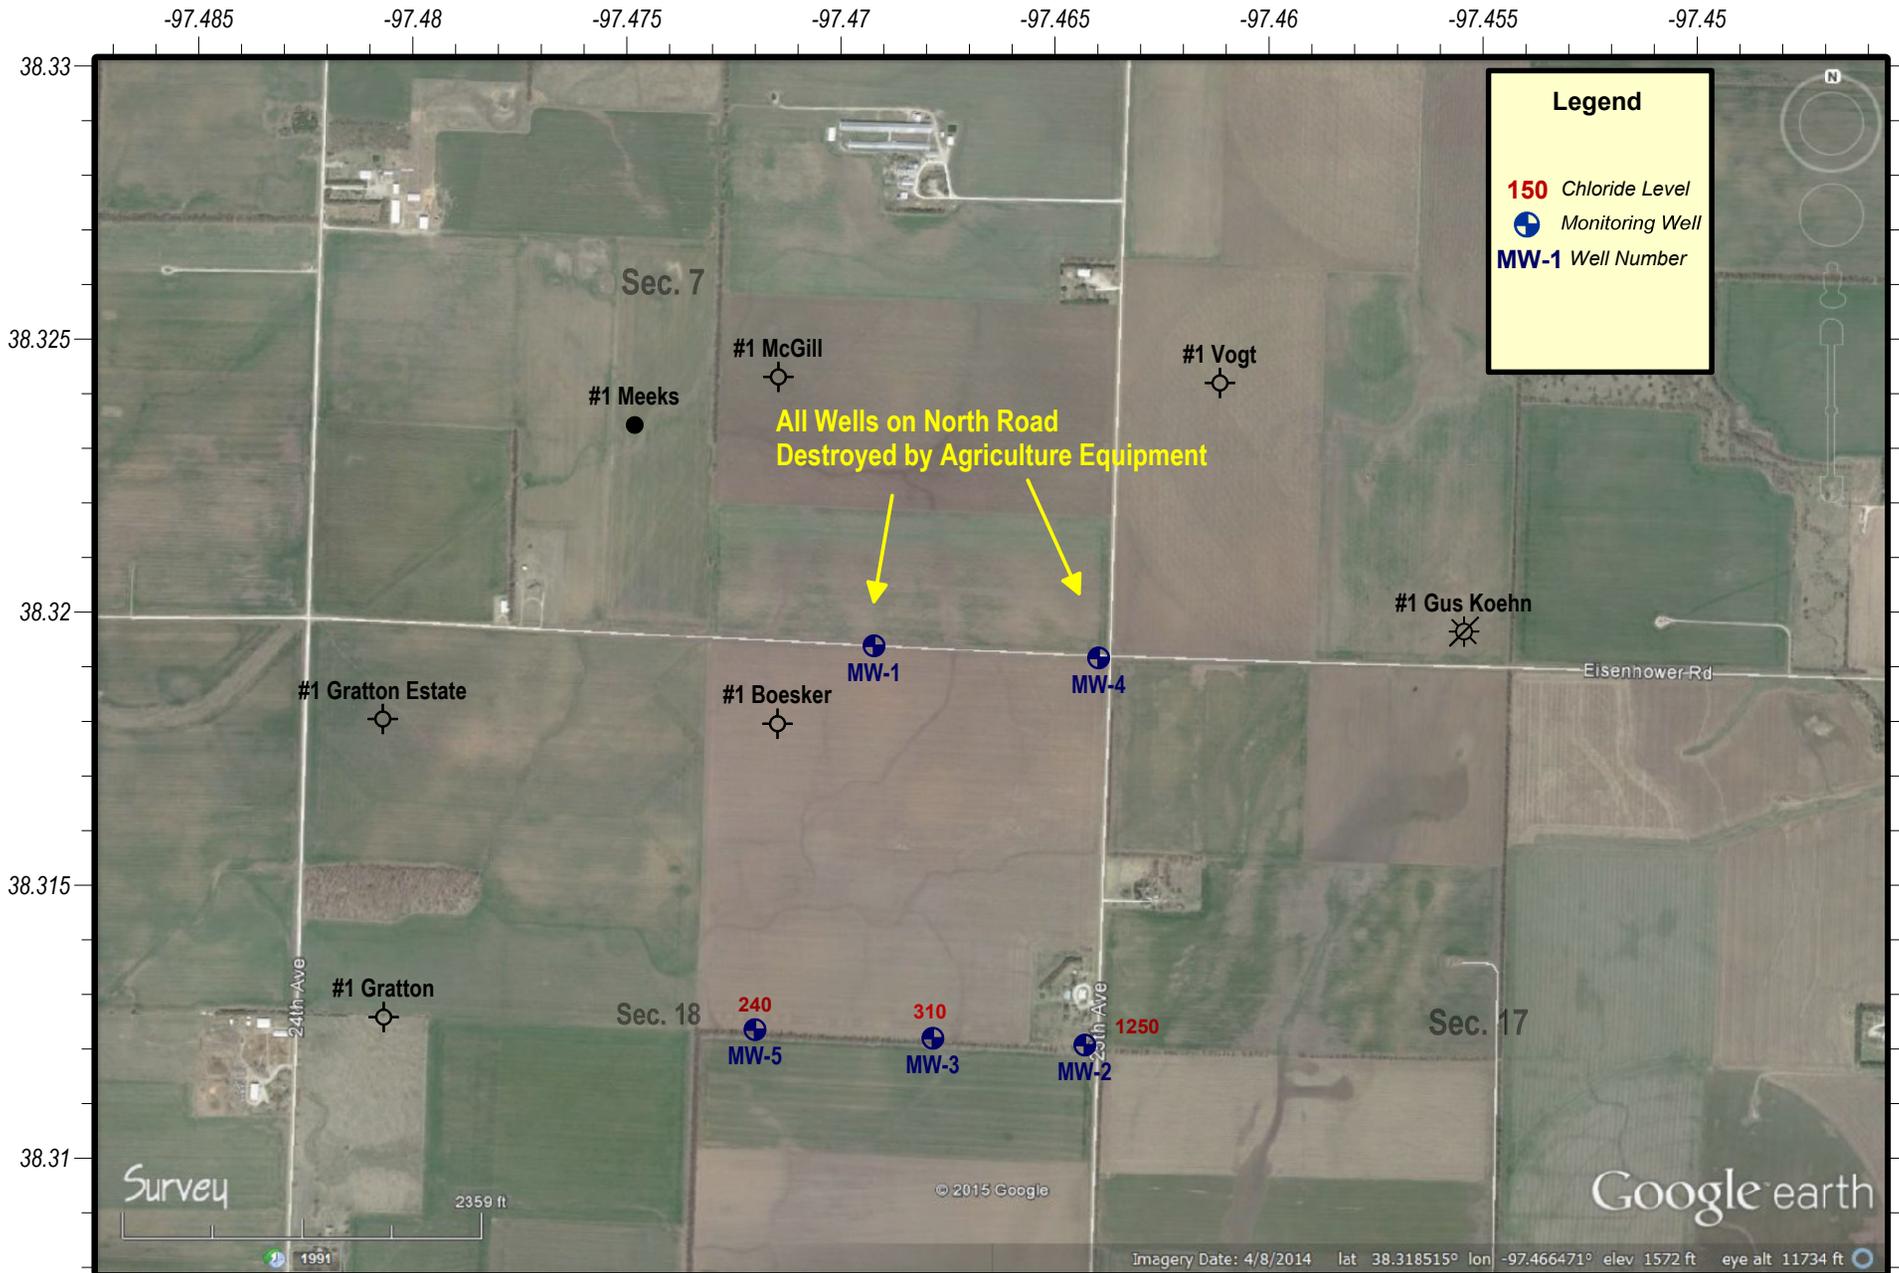
Nikkel- Epps Contamination Site
 NE Section 18 of T20S & R1W, McPherson County, Kansas
2015 Deep Monitoring Well Chlorides
 District #2 - Control # 20100082-001 - Drawn on: 11/12/2015 by D.Bollenback
