**OIL & GAS
REMEDIATION SITE STATUS
REPORT | 2016**

**Abandoned Oil and Gas Well / Remediation Site Fund
Remediation Sites
Status Report**

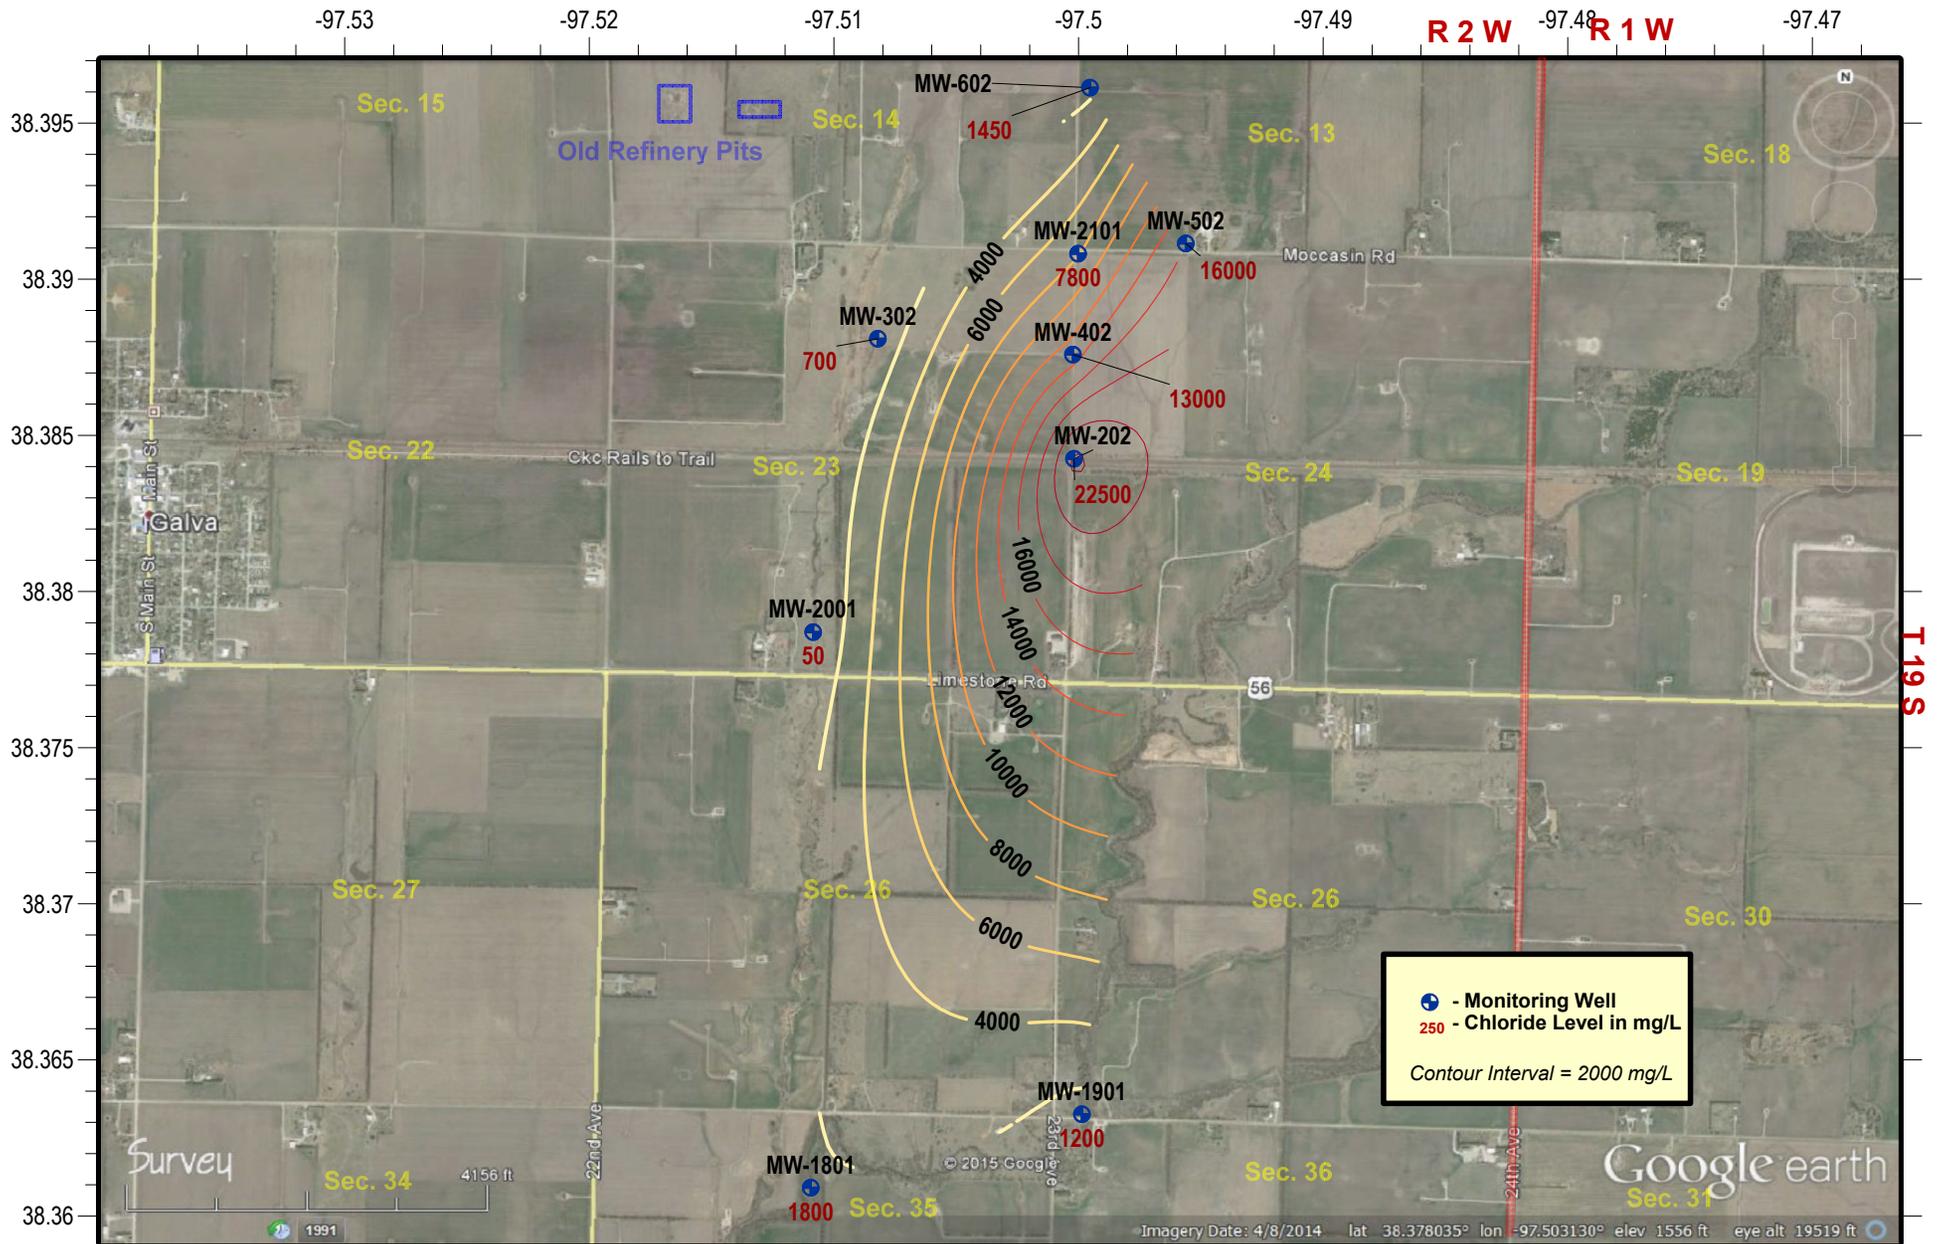
Northern Running Turkey Creek Contamination and Monitoring Site - KCC Control #20030059-001
 Multiple sections in Township 19 & 20 South and Range 2 West, McPherson County, Kansas
2015 Groundwater Chloride Levels
 District #2 - Sampled 10/13/2015 - Map Drawn on 11/13/2015 by D.Bollenback

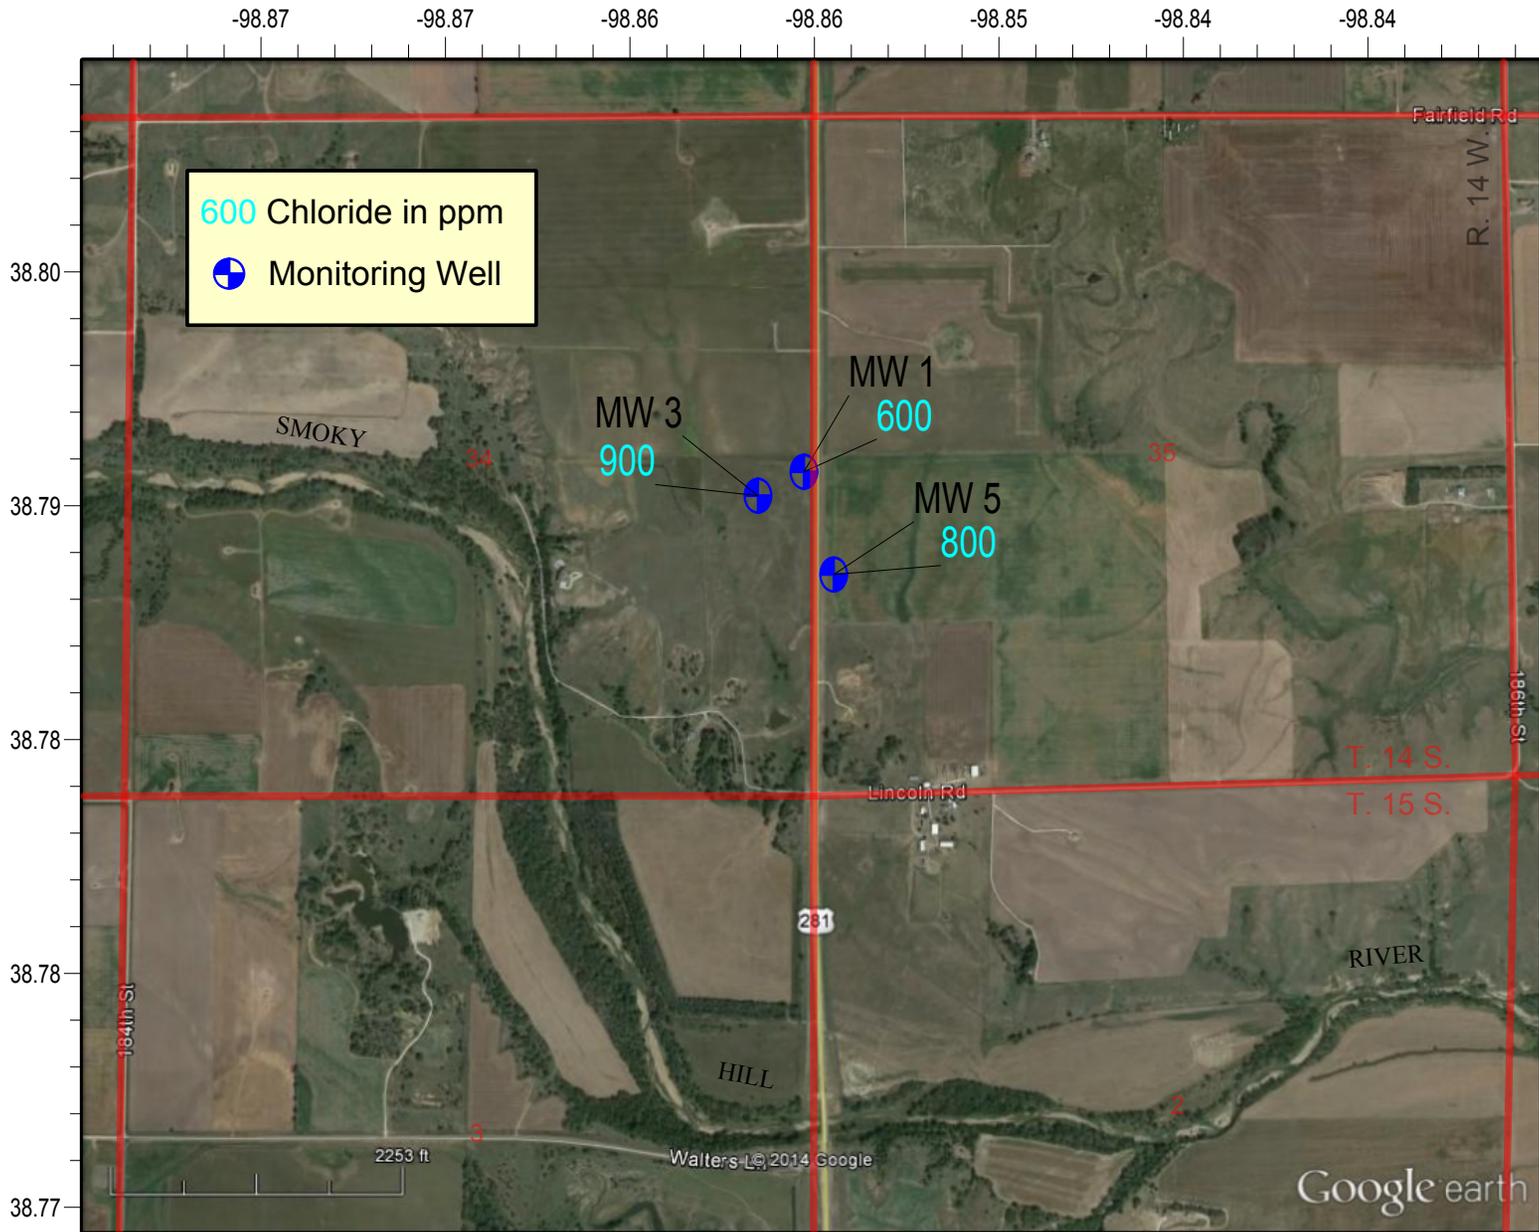
Russell Rural Water District #1 Groundwater Monitoring Site
 Sections 34 and 35, Township 14 South, Range 14 West, Russell County, Kansas
 2015 Groundwater Chloride Levels
 District #4 - Sampled 8/13/2015 - Map Drawn on 8/17/2015 by C. Neeley

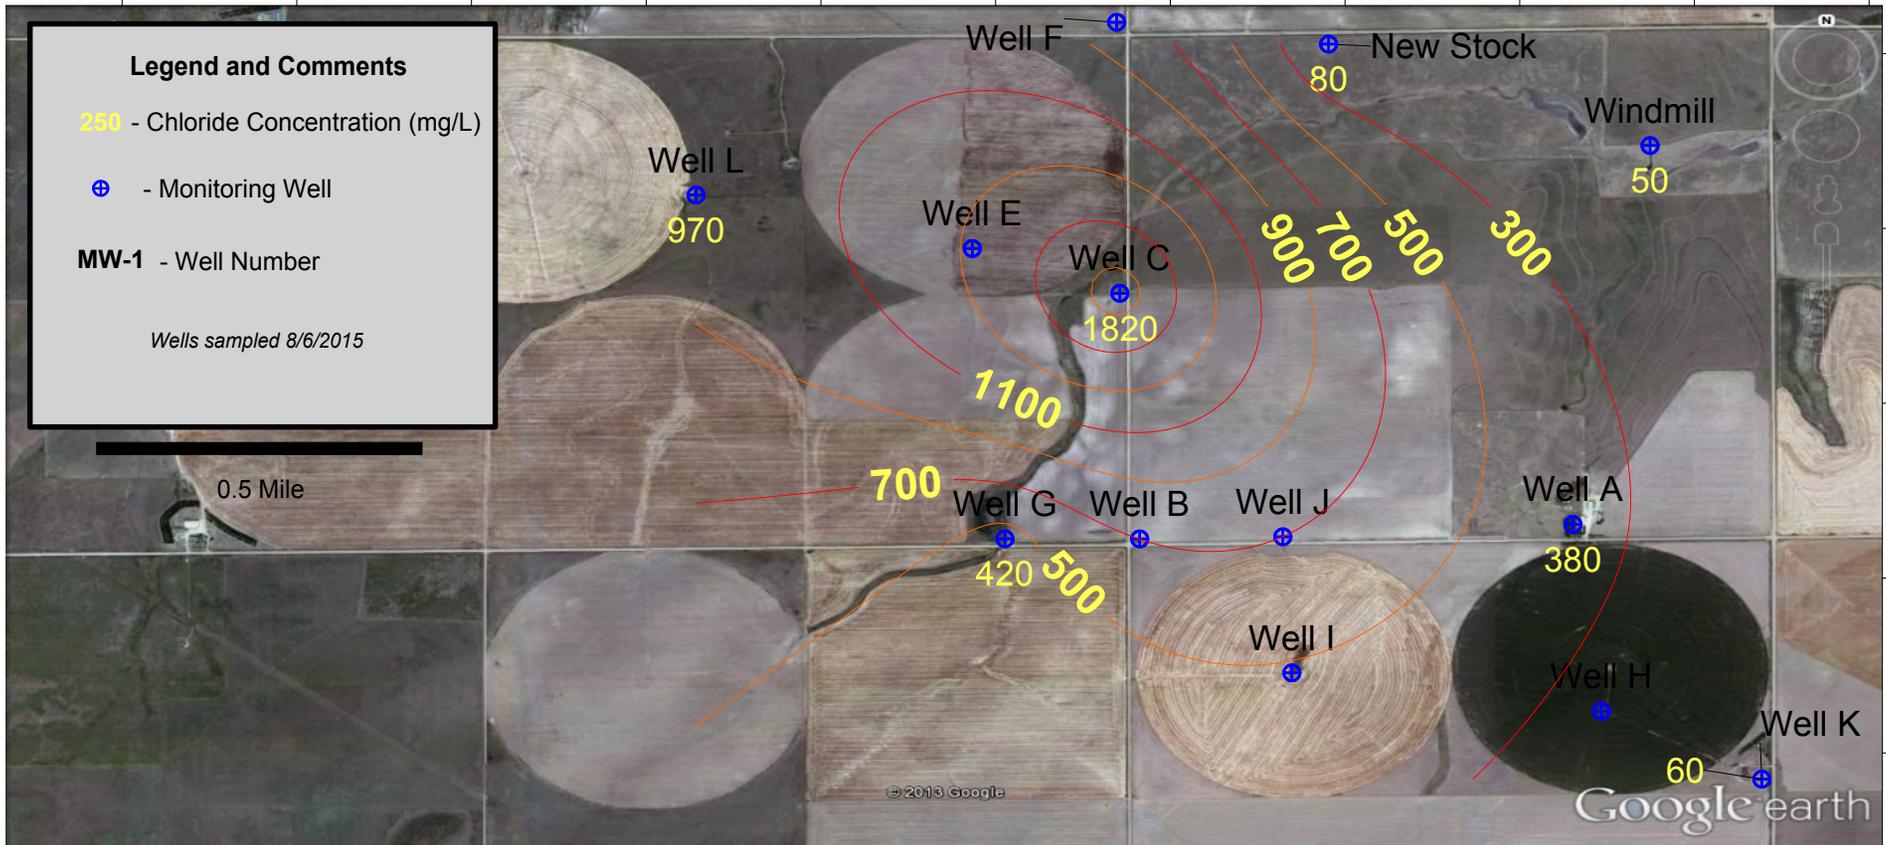
Schraeder Site
 Sections 2/3/11-T-24S-R24W
 Hodgeman County, Kansas
2015 Area Map with Chlorides
 KCC Control # 970013-00 District 1
 K. Sullivan 8/13/15

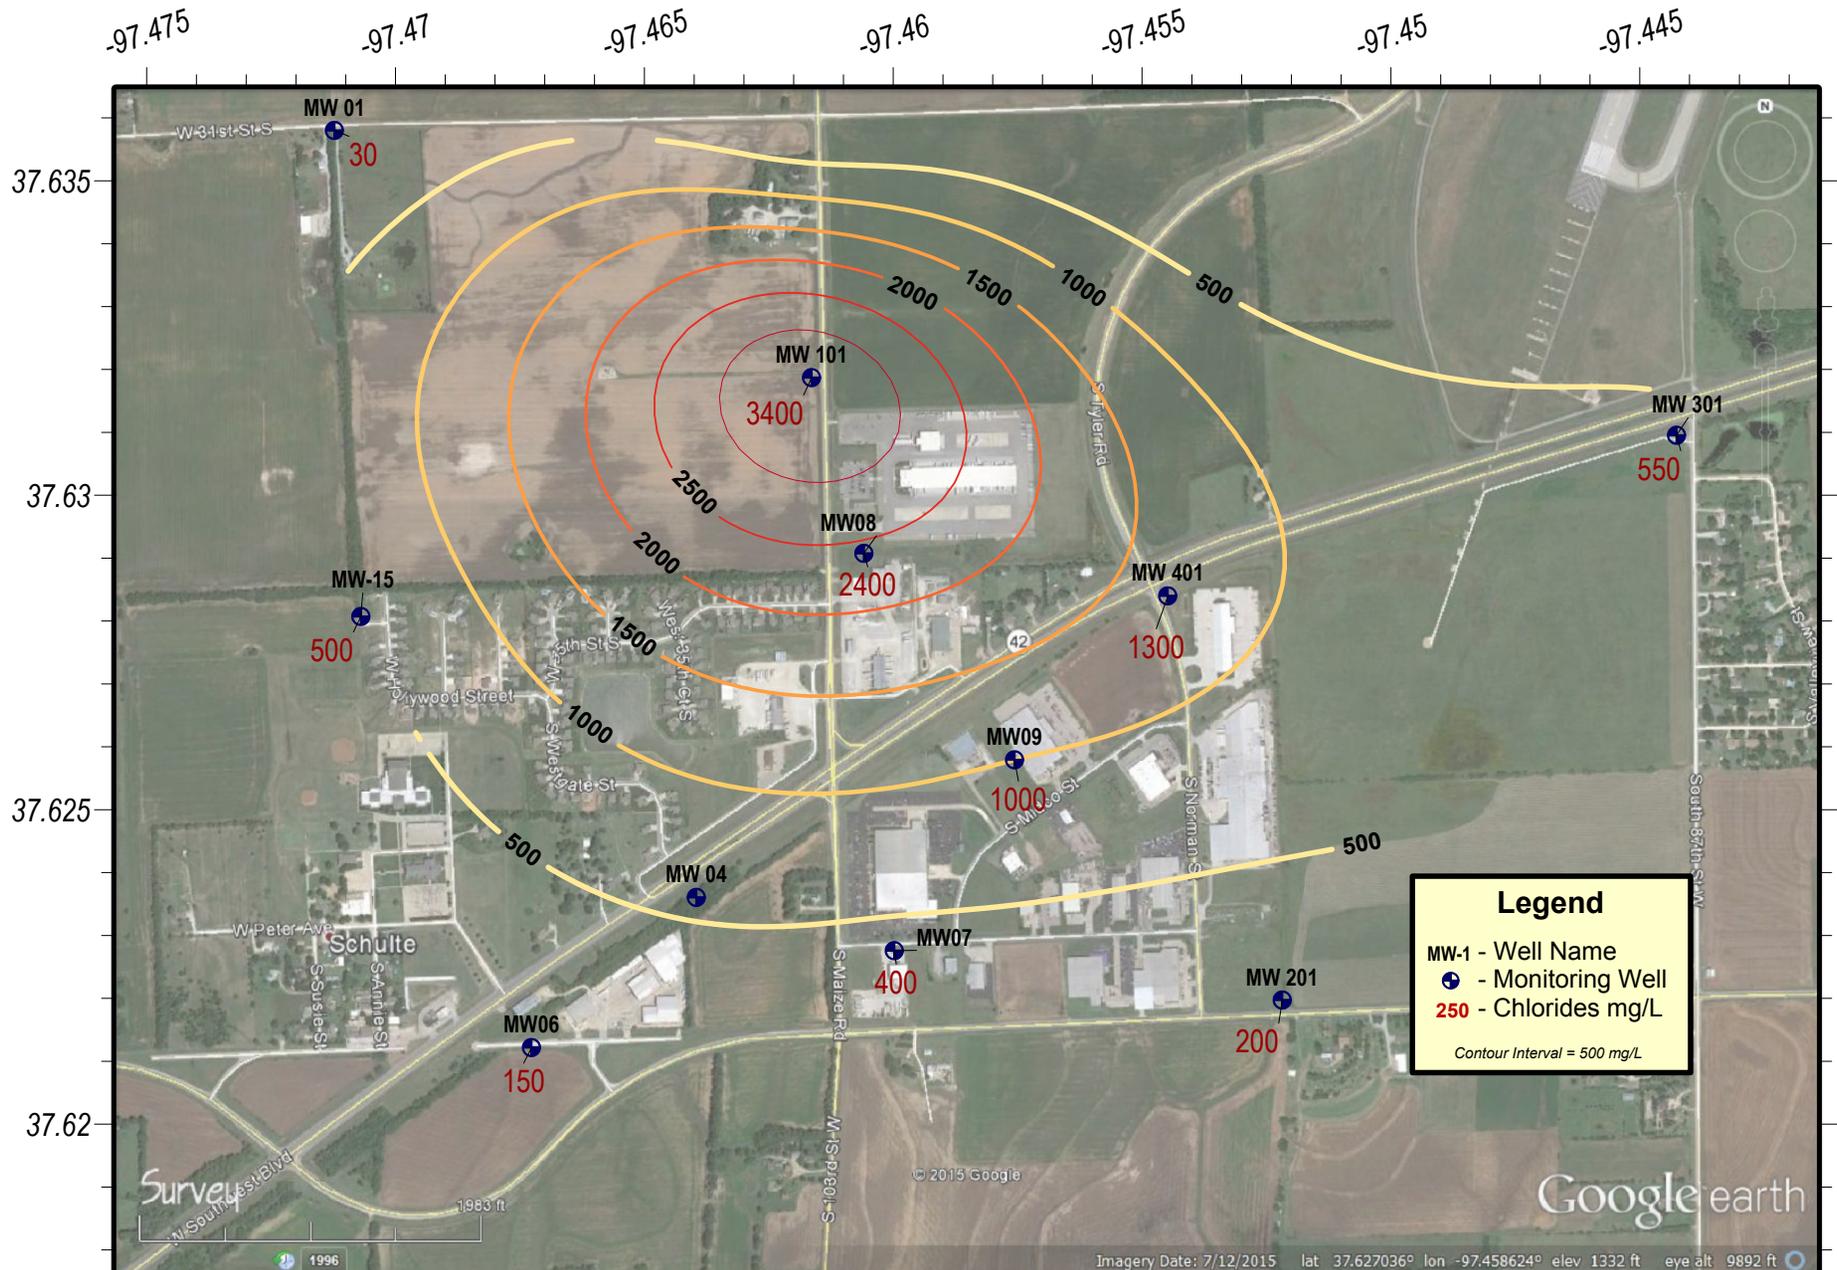
Schulte Remediation Site
 Sections 7 & 8 of Township 28 and Range 1 West, Sedgwick County, Kansas
2015 Monitoring Well Chloride Levels
 KCC Project Code #970015-00 - KCC District #2 Field Office
 Site Wells sampled on 6/8/2015 - Map Drawn 10/21/2015 by D. Bollenback

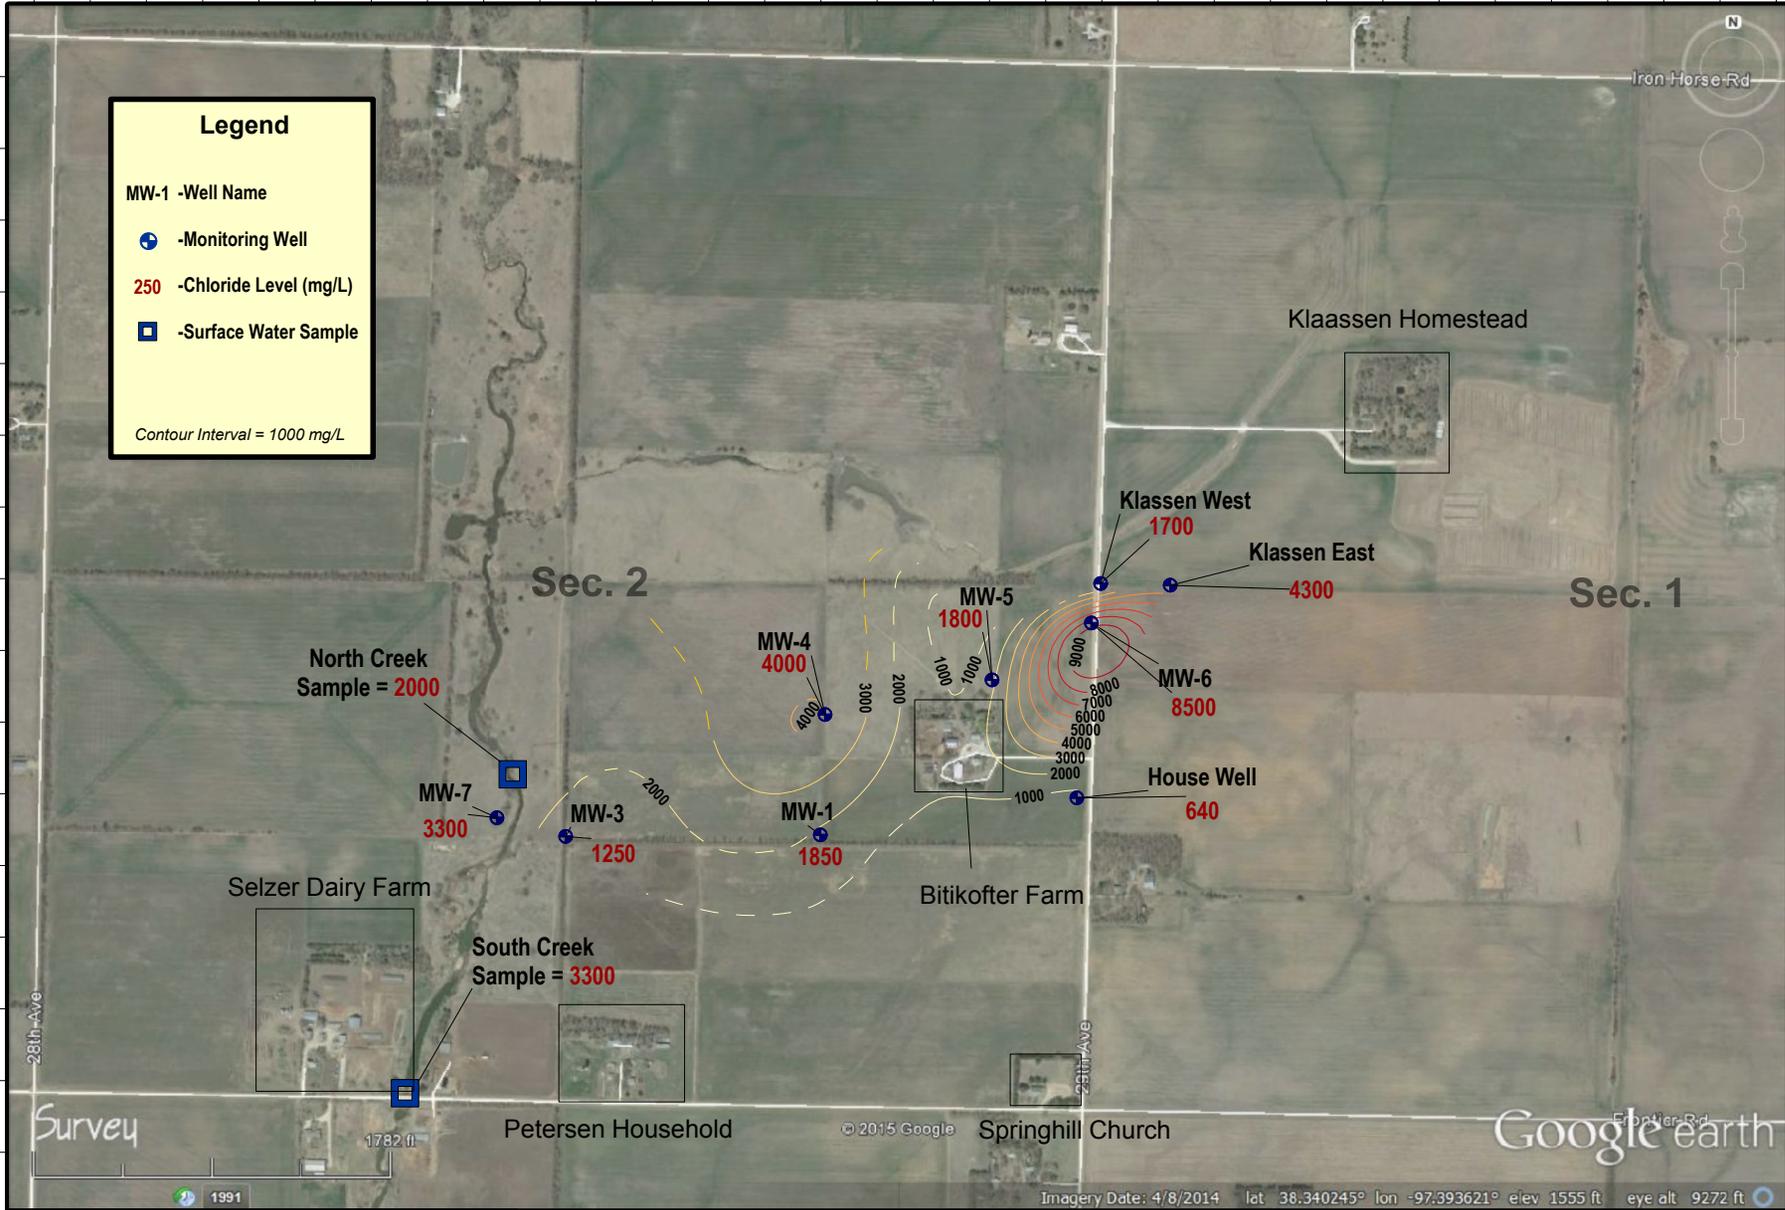
Seltzer-Bitikofter Brine Contamination Site
 Sections 1 and 2 of Township 20 South and Range 1 West, McPherson County, Kansas
2015 Chloride Levels
 KCC Project Code #970093-00 - KCC District #2 Field Office - Wells Sampled on 9/16/2015 - Map Drawn on 11/19/2015 by D.Bollenback

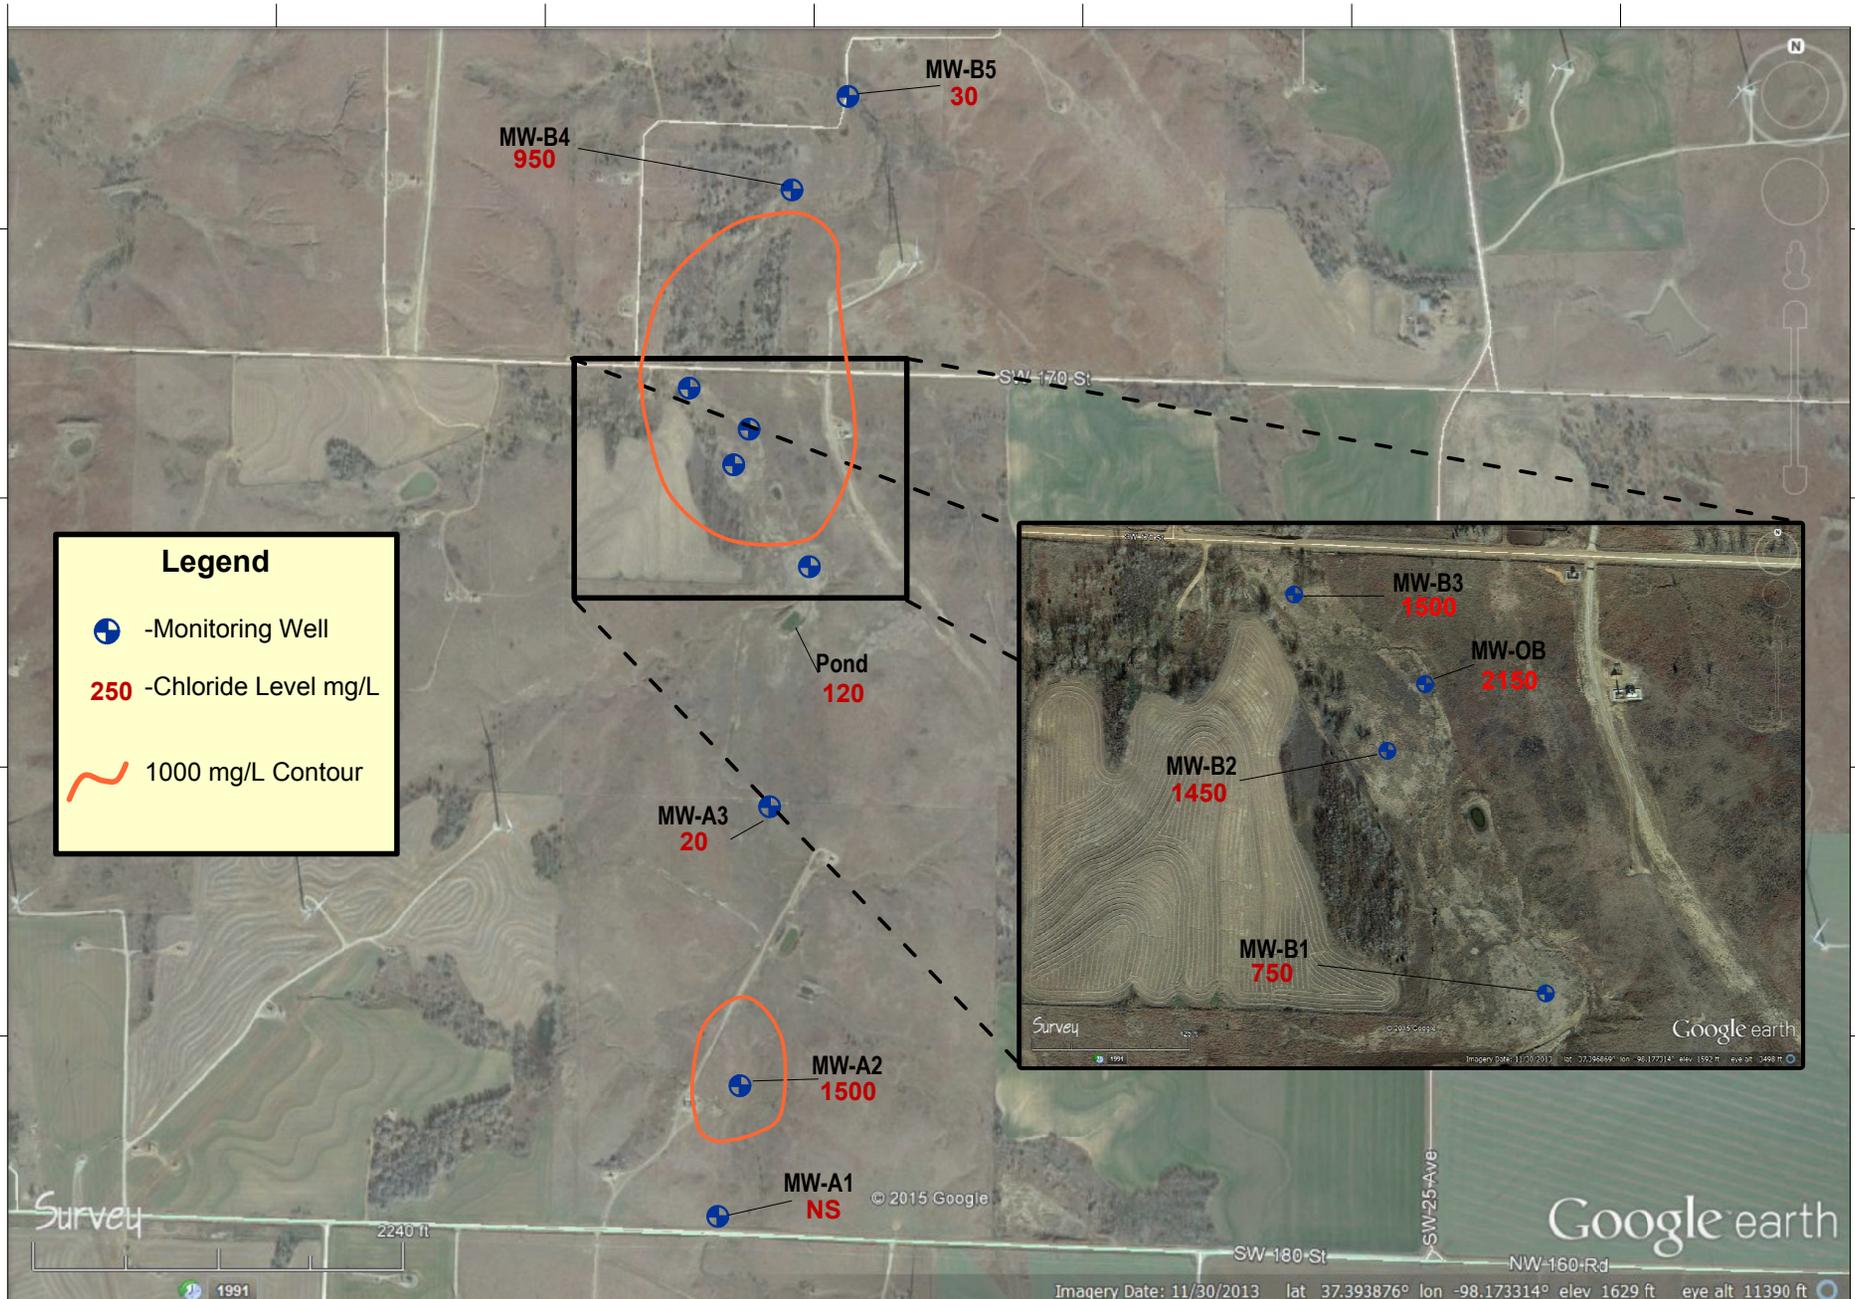
South Spivey Brine Monitoring Site
 Sections 27 & 34 of Township 30 South and Range 8 West, Kingman County, Kansas
Site Chloride Levels 2015-16
 KCC District #2 Field Office - Site well sampled on 8/27/2015 - Map Drawn on 10/28/2015 by D.Bollenback

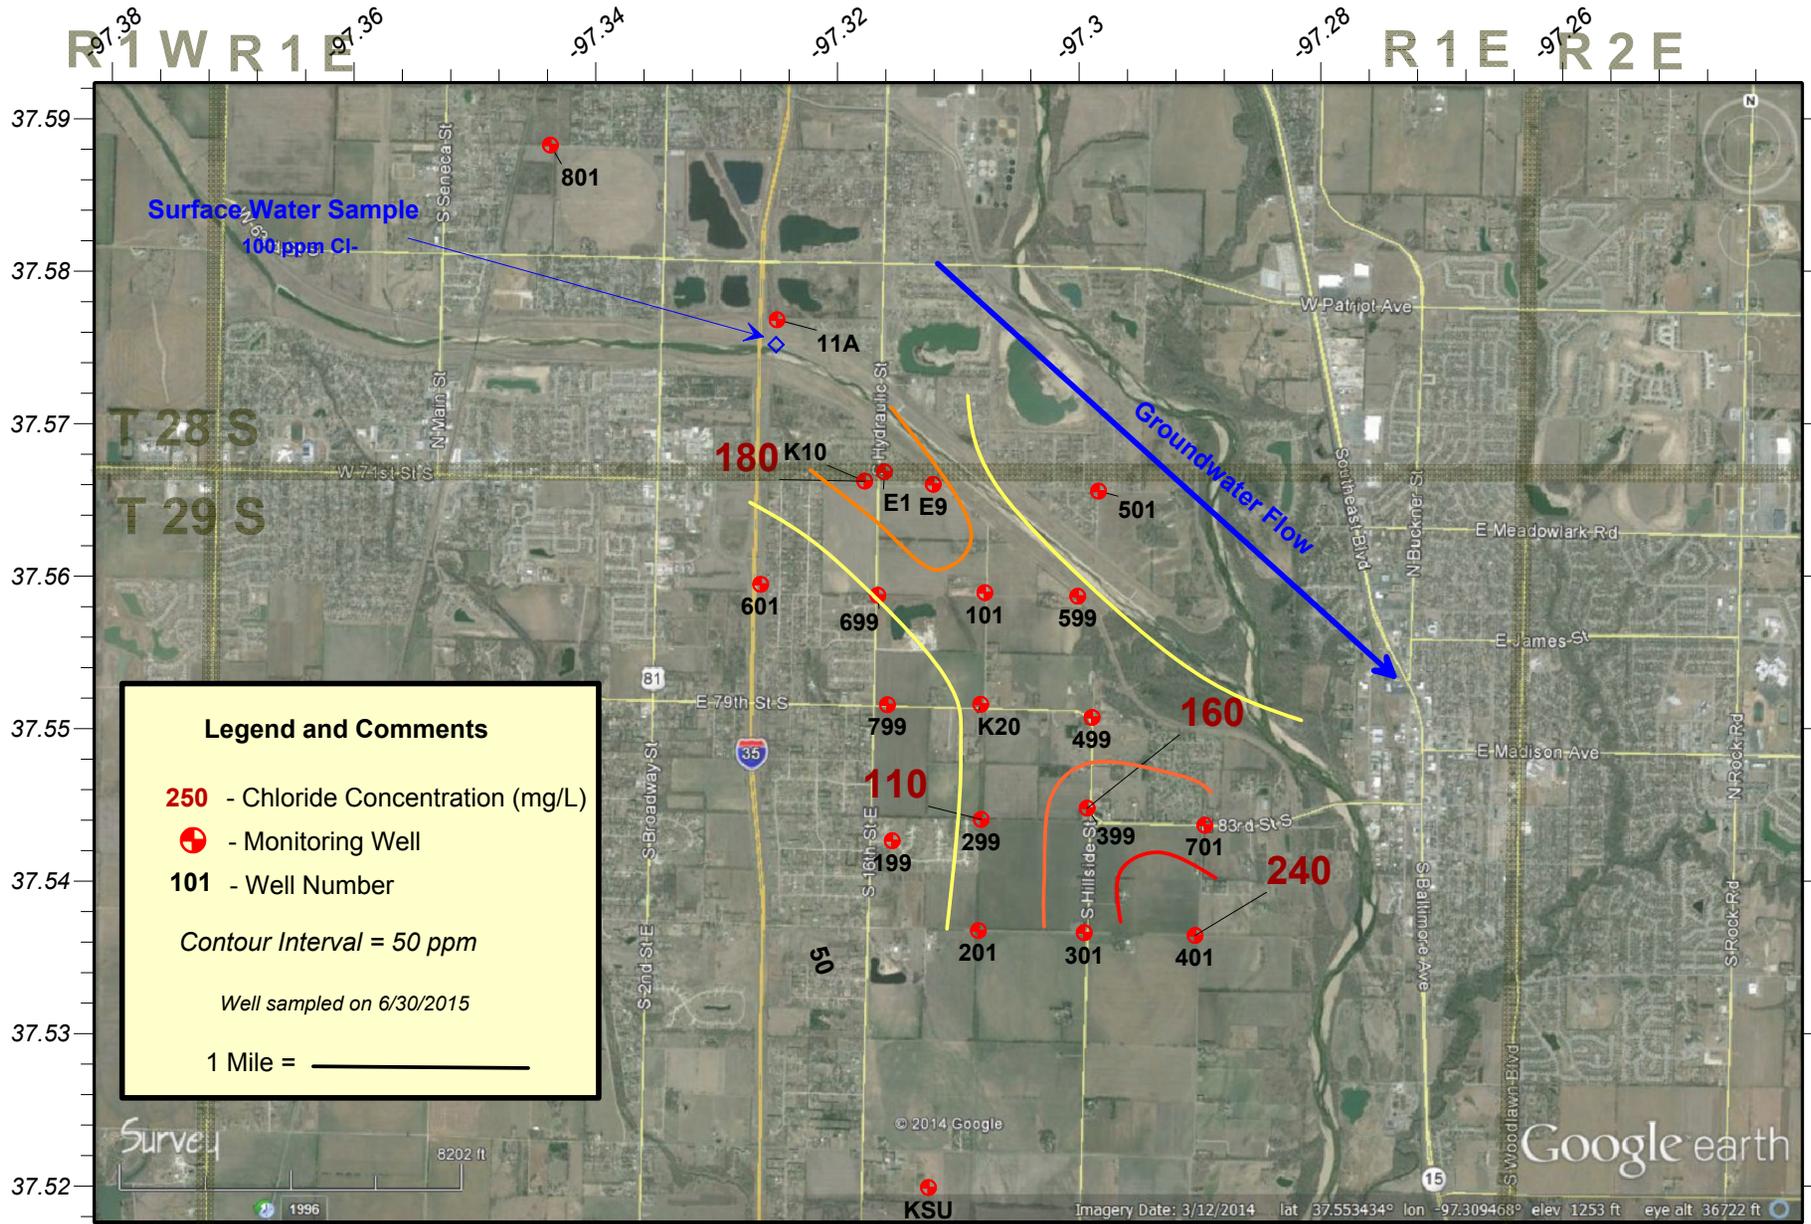
South Wichita Brine Monitoring Site
 Multiple Sections of Township 28 & 29 South and Range 1 East, Sedgwick County, Kansas
2015 Limited Sampling - Chloride Concentrations
 KCC Project Code #970016-00 - KCC District #2 Field Office - Maps Drawn on 11/9/2015 by D.Bollenback

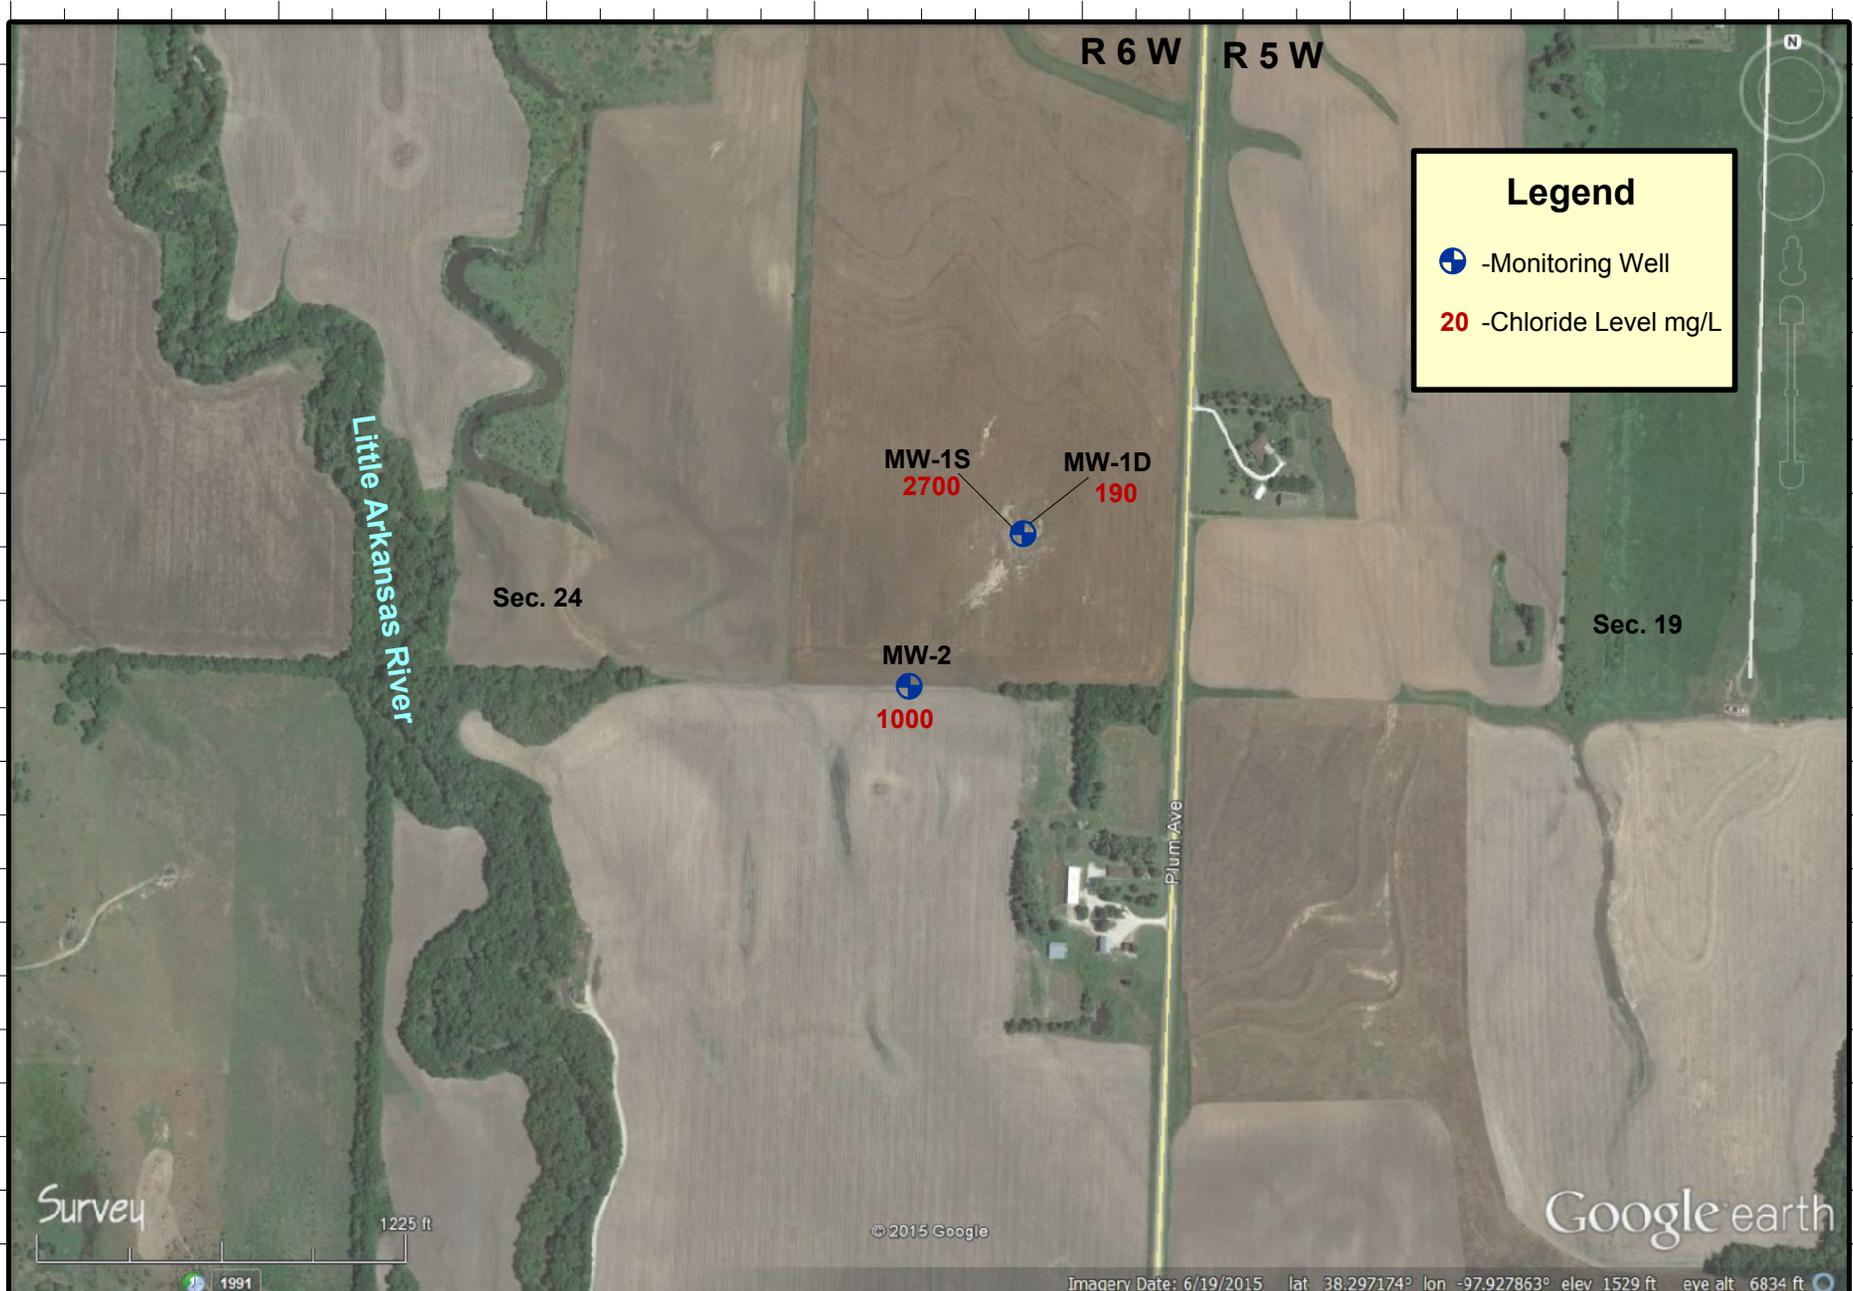
Stowie-Zaid Shallow Brine Monitoring Site
 Section 24 of Township 20 South and Range 6 West, Rice County, Kansas
2015-16 Chloride Levels
 KCC District #2 Field Office - Wells sampled on 8/4/2015 - Map drawn on 10/27/2015 by D.Bollenback

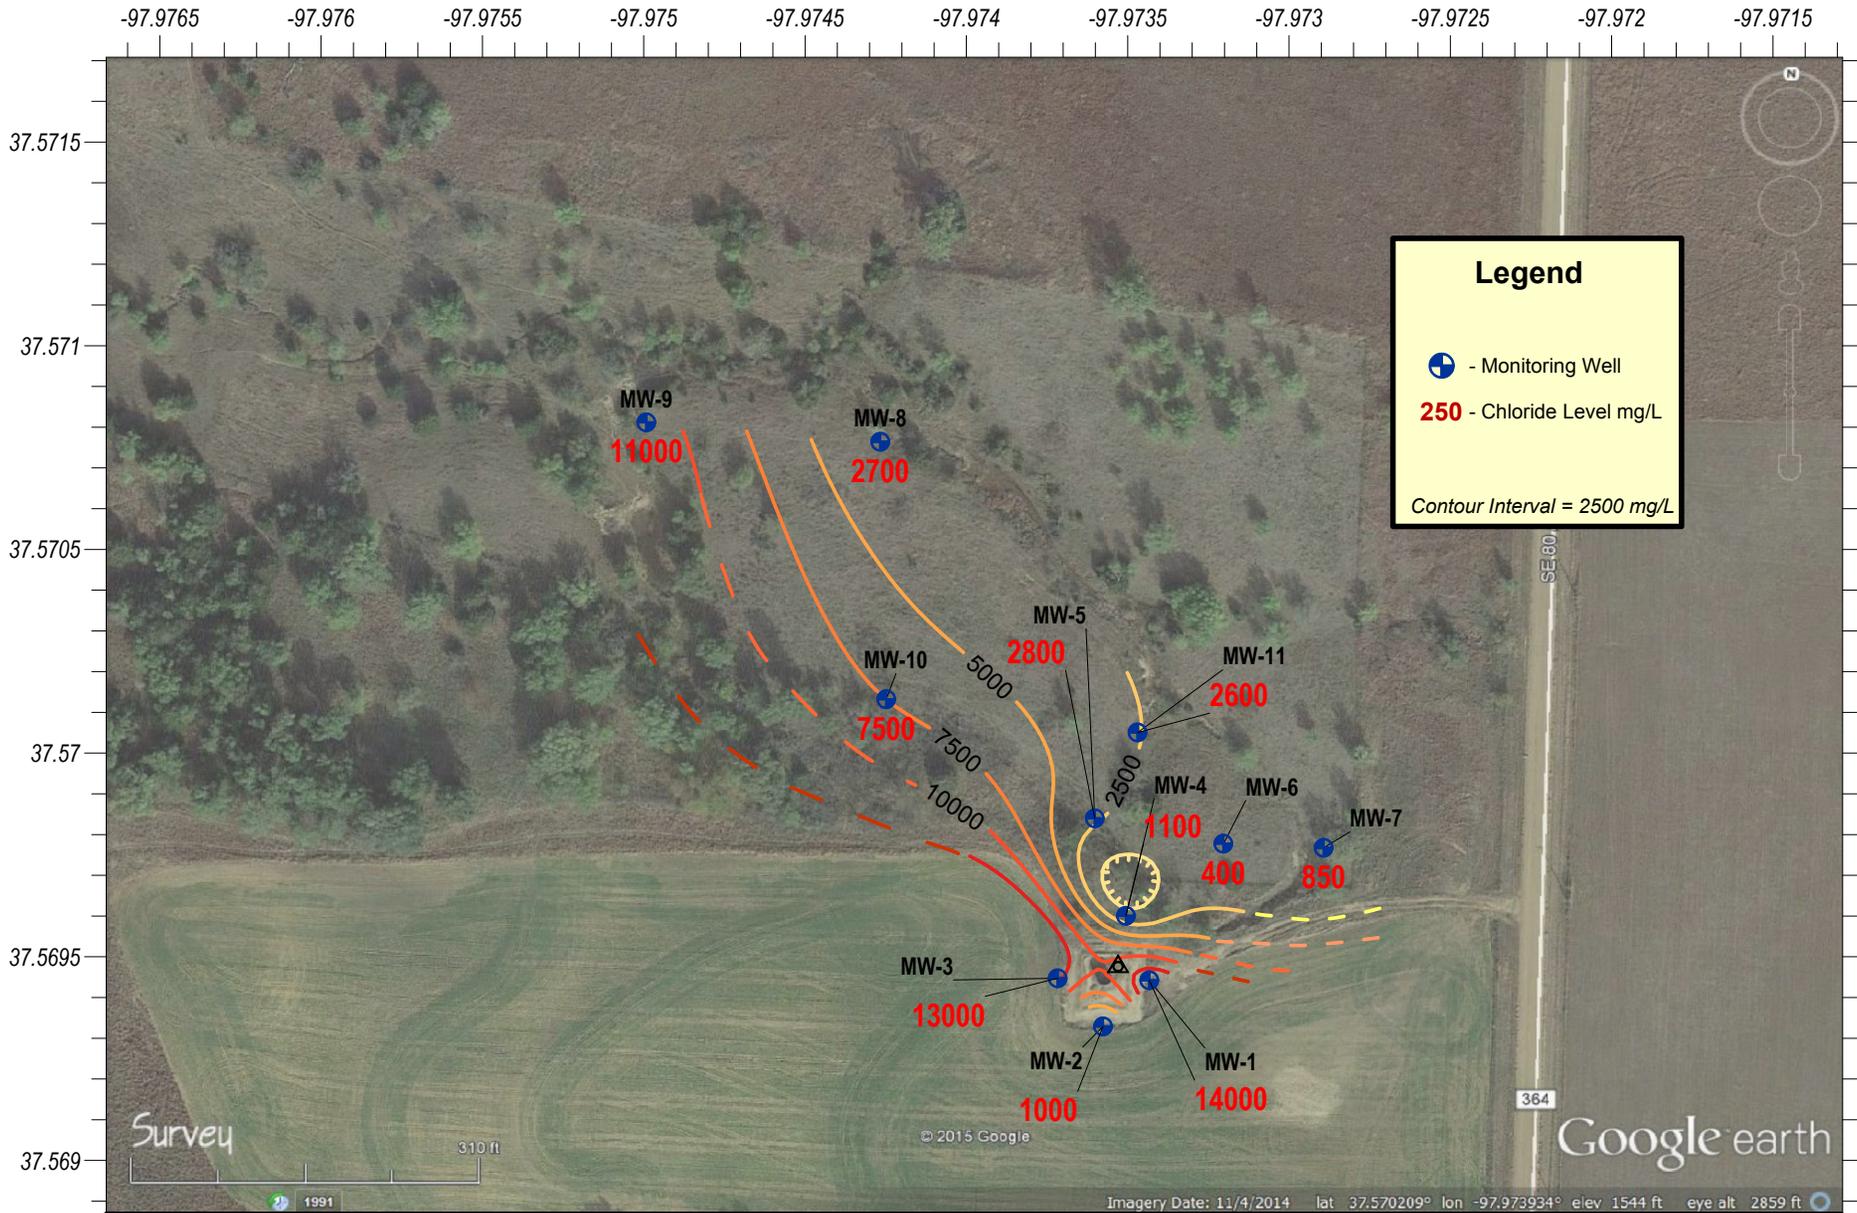
Trostle Post-Remediation Brine Monitoring Site
 Section 33 of Township 28 South and Range 6 West, Kingman County, Kansas
2015 Chloride Levels
KCC Control #980038-001 - Wells sampled on 7/16/2015 - Map Drawn on 10/28/2015 by D.Bollenback

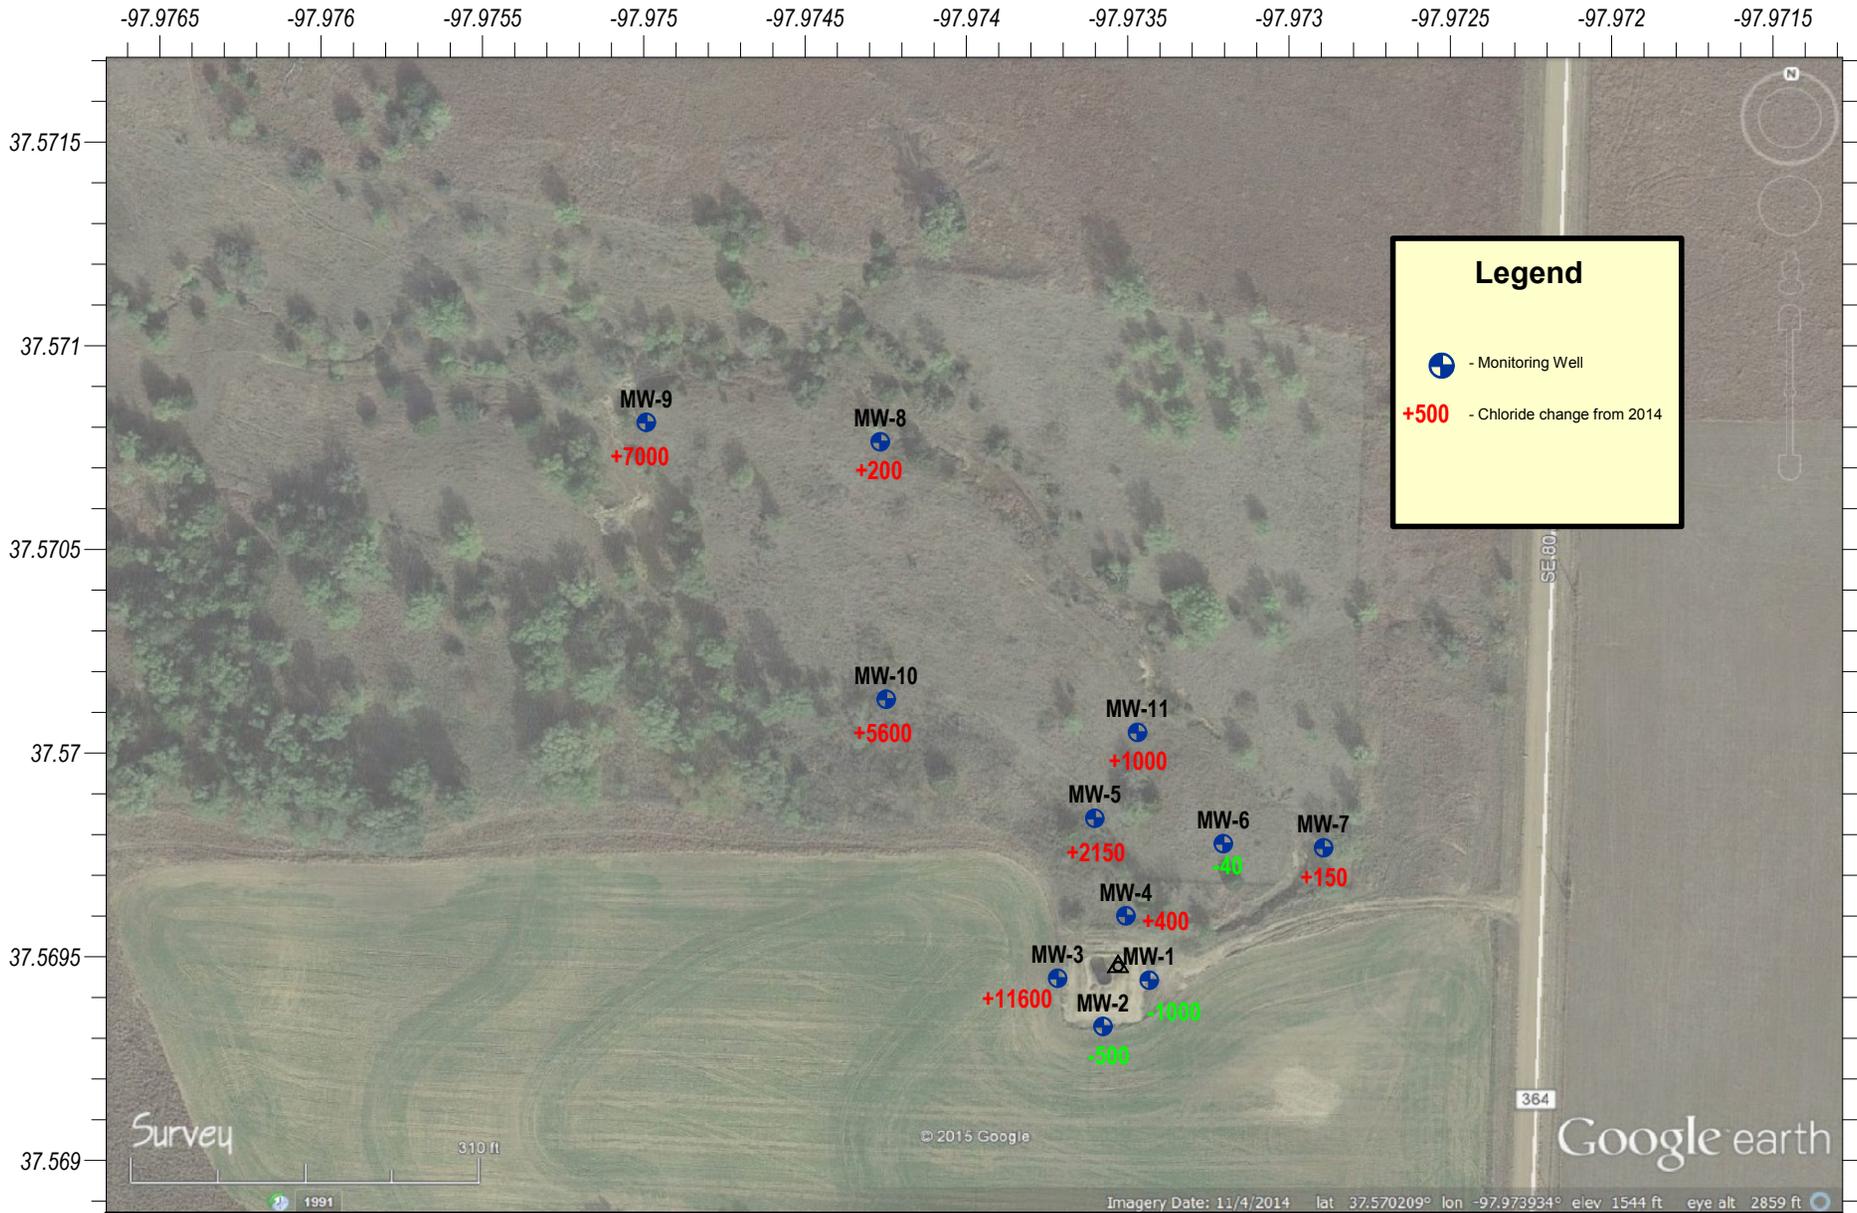
Trostle Post-Remediation Brine Monitoring Site
 Section 33 of Township 28 South and Range 6 West, Kingman County, Kansas
2015 Site Map Showing Chloride Level Changes From 2014
 KCC Control #980038-001 - Wells sampled on 7/16/2015 - Map Drawn on 10/28/2015 by D.Bollenback
