**OIL & GAS
REMEDIATION SITE STATUS
REPORT | 2016**

**Abandoned Oil and Gas Well / Remediation Site Fund
Remediation Sites
Status Report**

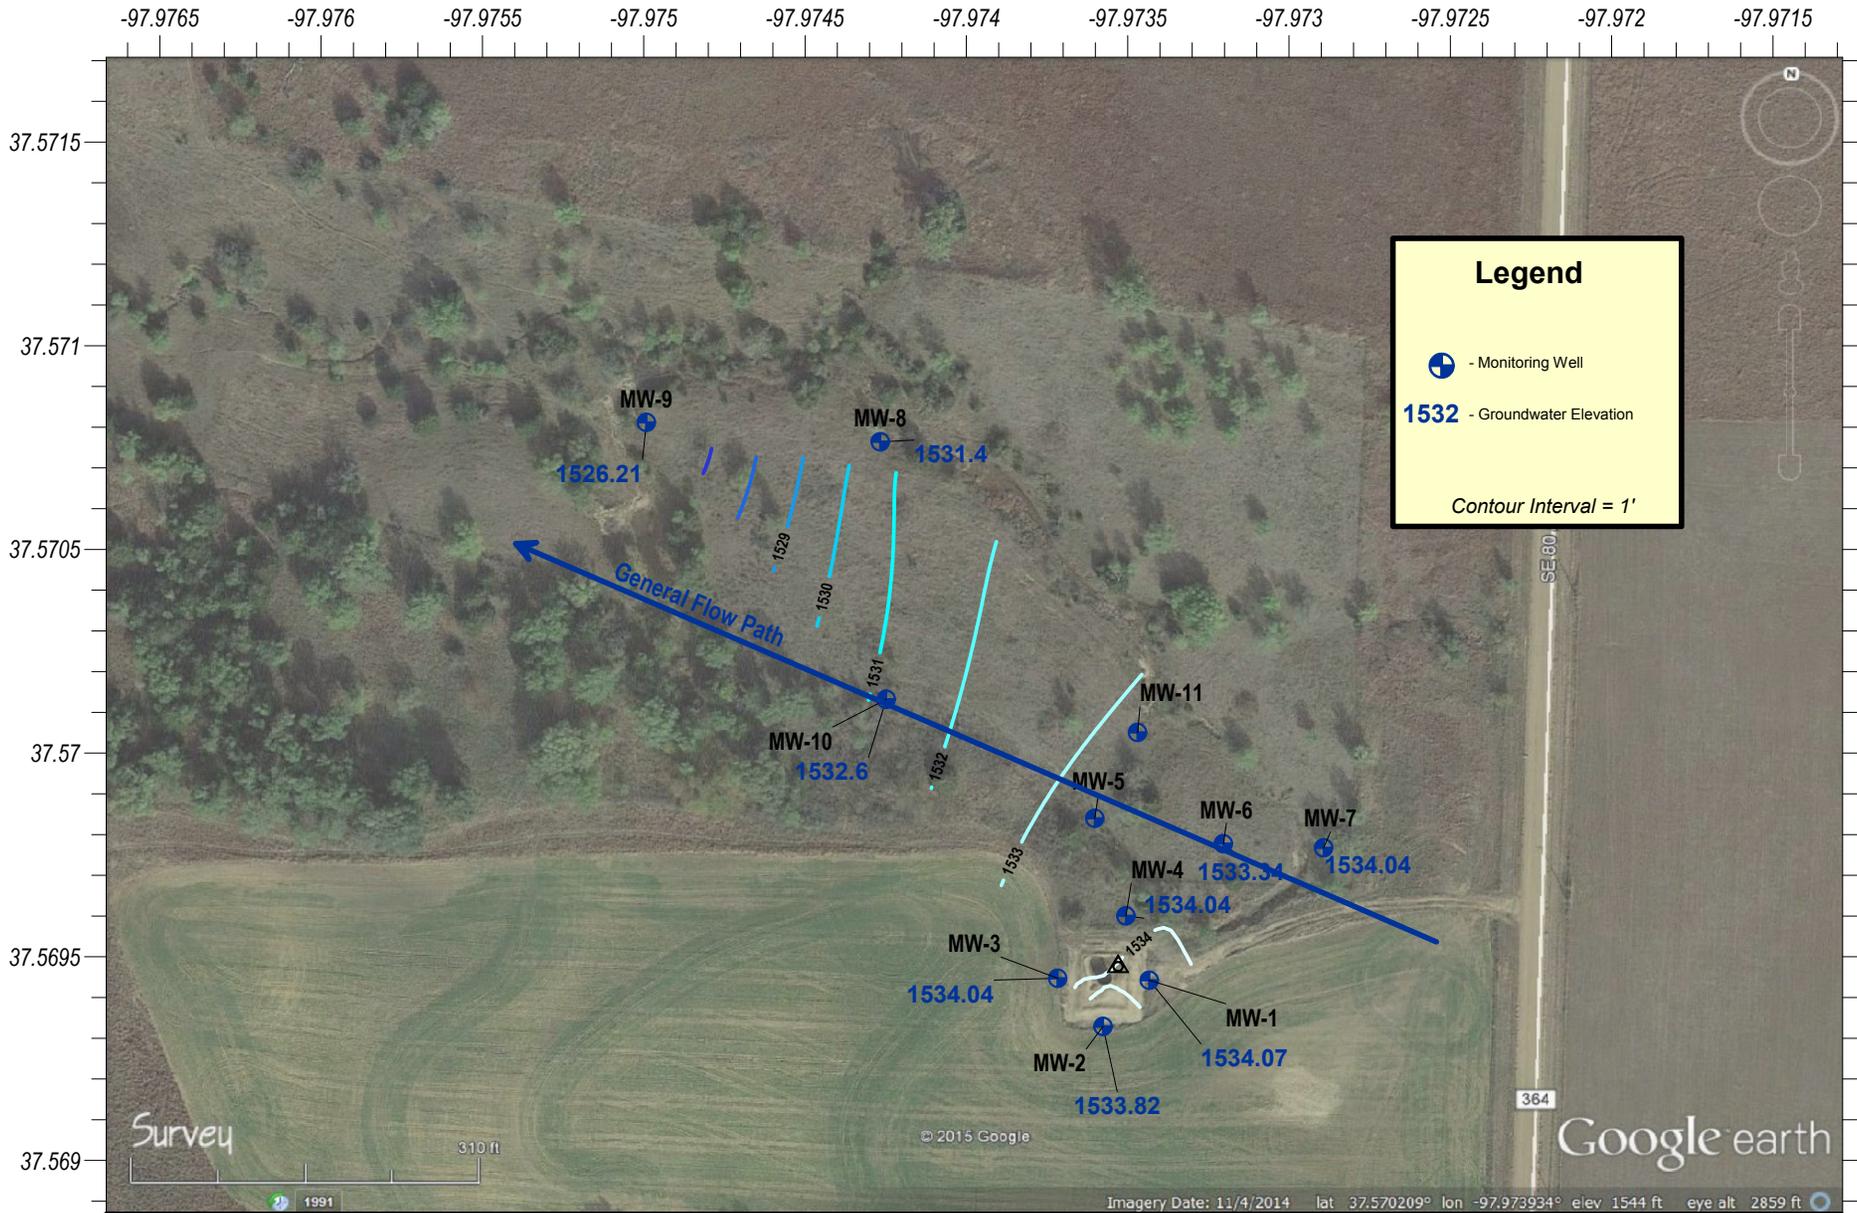
Trostle Post-Remediation Brine Monitoring Site
 Section 33 of Township 28 South and Range 6 West, Kingman County, Kansas
2015 Groundwater Elevation Map
 KCC Control #980038-001 - Wells sampled on 7/16/2015 - Map Drawn on 10/28/2015 by D.Bollenback

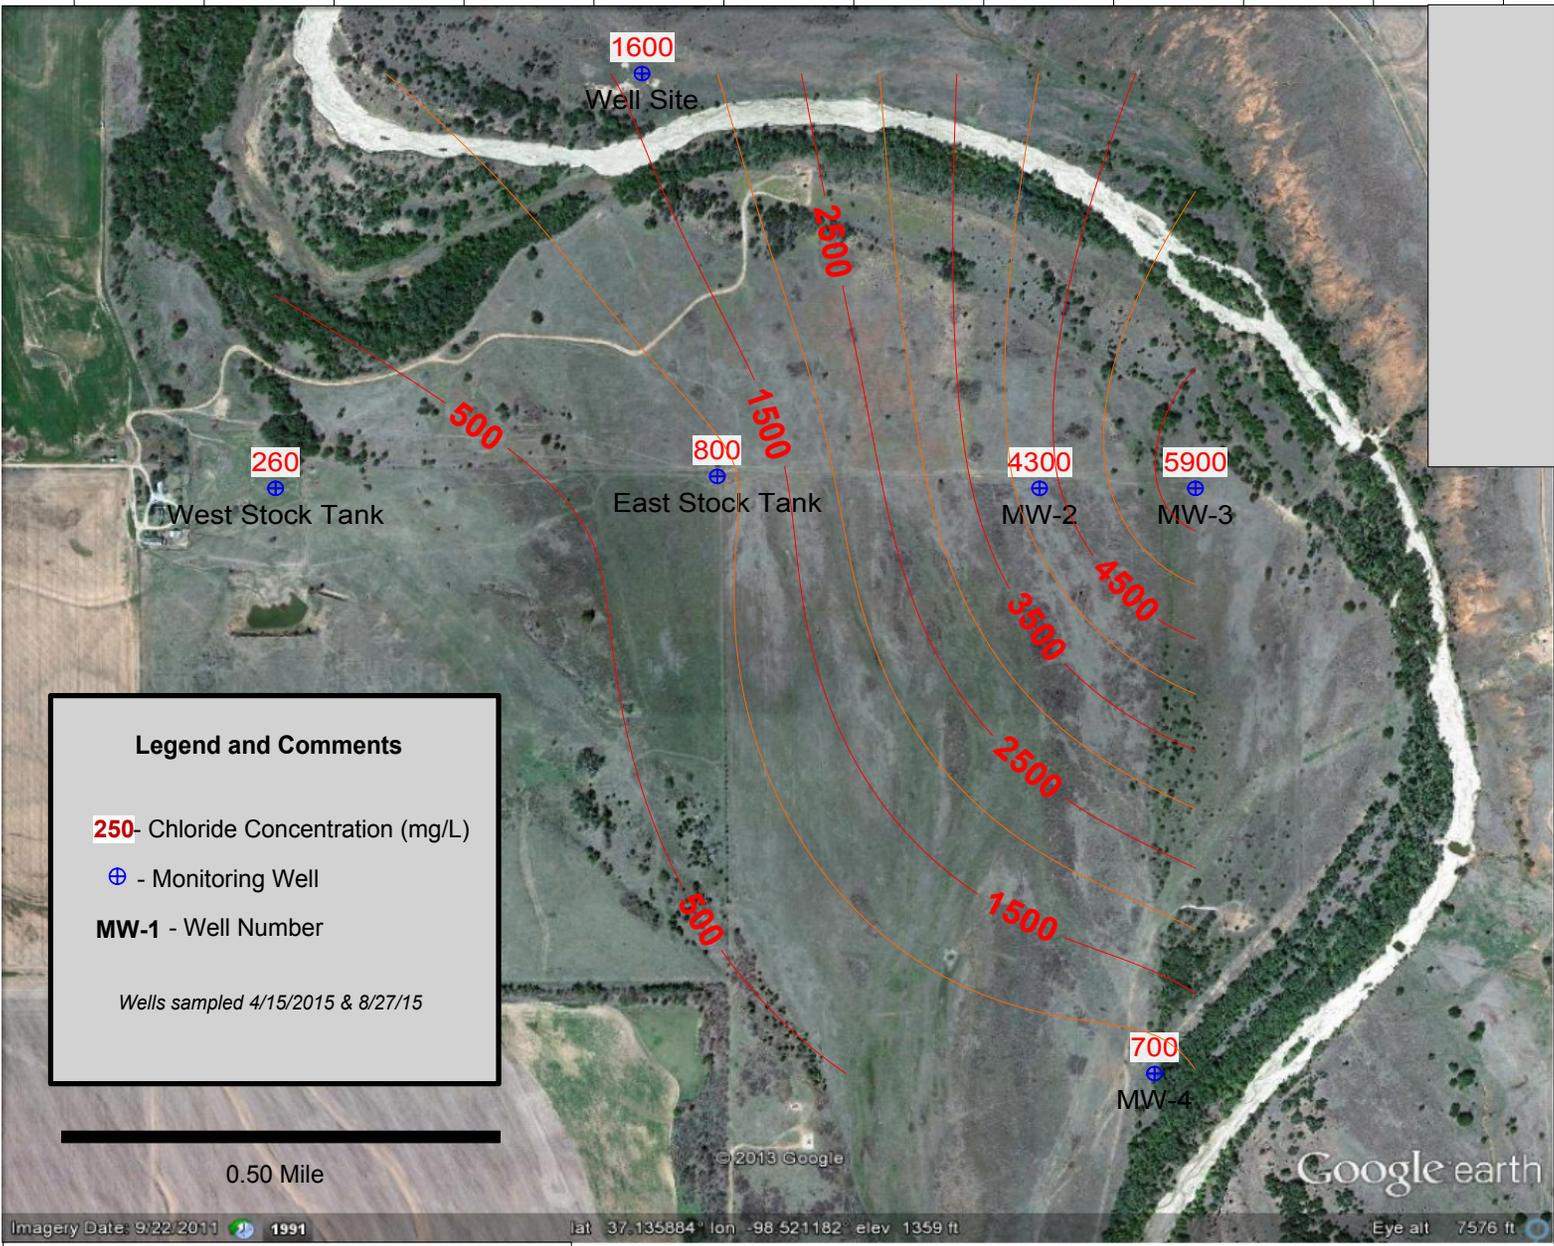
Wildboys Site
2015 Area Map with Chlorides
 Sections 28/33-T-33S-R11W
 Barber County, Kansas
 KCC Control # 970017-00 District 1
 K. Sullivan 8/28/15

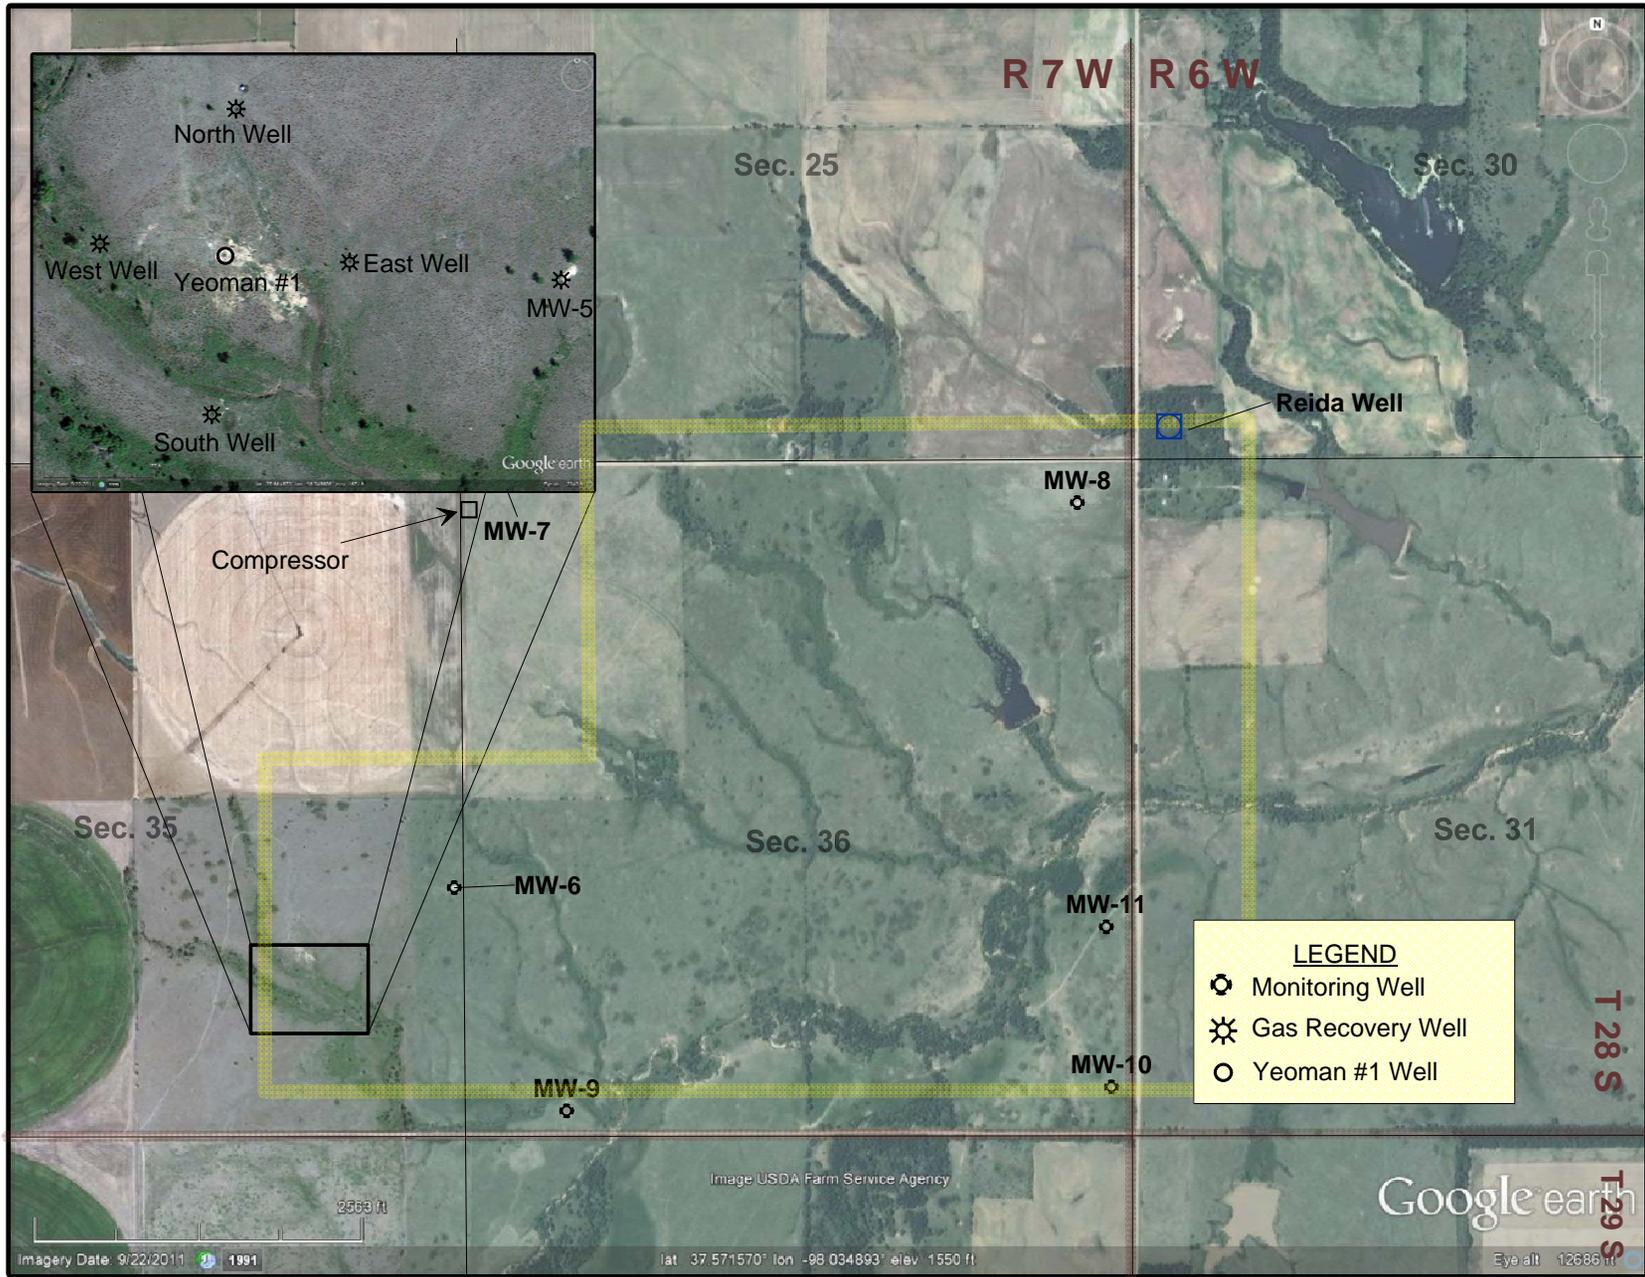
Yeoman Escaped Shallow Gas Site
SE/4 of Section 35 and All of Section 36-T28S-R7W, Kingman Co., KS
Site Map for 2015-16 Legislative Reports
District #2 Control No. 20060021-001 10-29-2015 D. Bollenback
